# **9819-7400-1.0.1: G70RS, G125RS T4F DC Help Files - English (en\_GB)**

## **USER MANUAL**

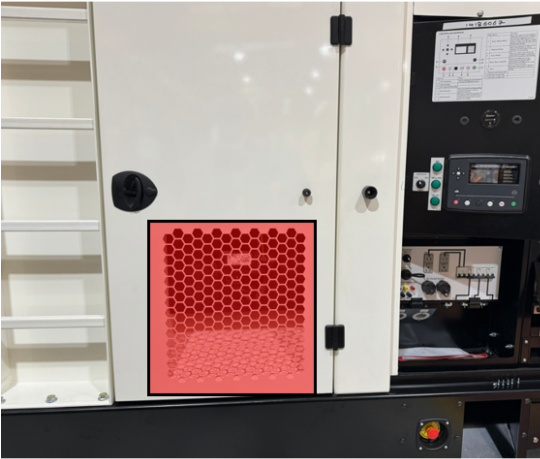
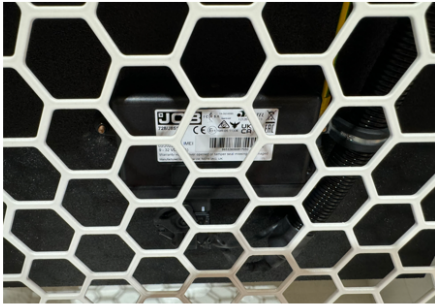
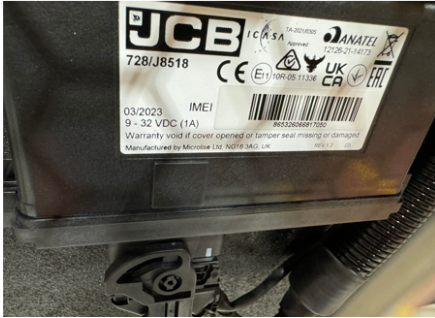
| <b>Location<br/>IMG:</b> | |

| <b>Function:</b> | Telematics Device to transmit machine live data to server |
| <b>Location:</b> | Canopy door |

| <b>Wires &amp;<br/>Connect<br/>ors IMG:</b> | Wire Number - C3 - 6003K<br>Wire Number - D4 - 4007K<br>Wire Number - E4 - 4006K<br>Wire Number - E2 - 3002<br>Wire Number - J1 - 4008<br>Wire Number - K1 - 4008<br>Wire Numbers - L3 - 6005A<br>Wire Numbers - L2 - 6004<br>Wire Numbers - M2 - 6005B<br>Wire Numbers - M4 - 3003 |

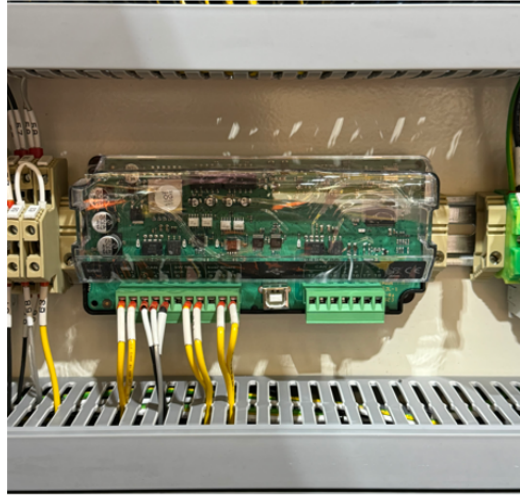
| <b>Location IMG:</b> | |

| <b>Function:</b> | <p>The DSE123 is an intelligent device that allows DSE 8610 load share modules to communicate with non-DSE control modules that are communicating over universal analogue load share lines. This means When we Synchronize Generator with DSE8610 with other generator controller having Analog based load share, then we need DSE123 to established communication between these controller for KW &amp; KVAR sharing.</p> |

| <b>Location:</b> | Inside Panel. |
| <b>Wires &amp; Connectors IMG:</b> | Wire Numbers - 4 and 7<br>Wire Numbers - 57 and 58<br>Wire Numbers -121,122 and 123 |

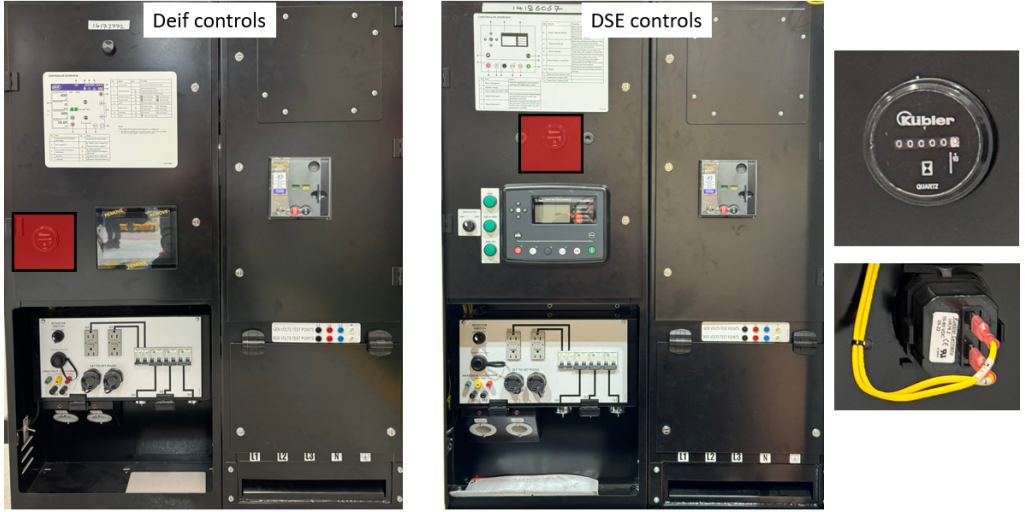
| <b>Location IMG:</b> | | |

| <b>Function:</b> | Hour Counter is a measuring instrument to measure the Generator running hour. |
| <b>Location:</b> | Panel Door. |

| <b>Wires &amp; Connectors IMG:</b> | Wire Numbers - 4 and 116<br>Wire Numbers - 4 and 114 | |

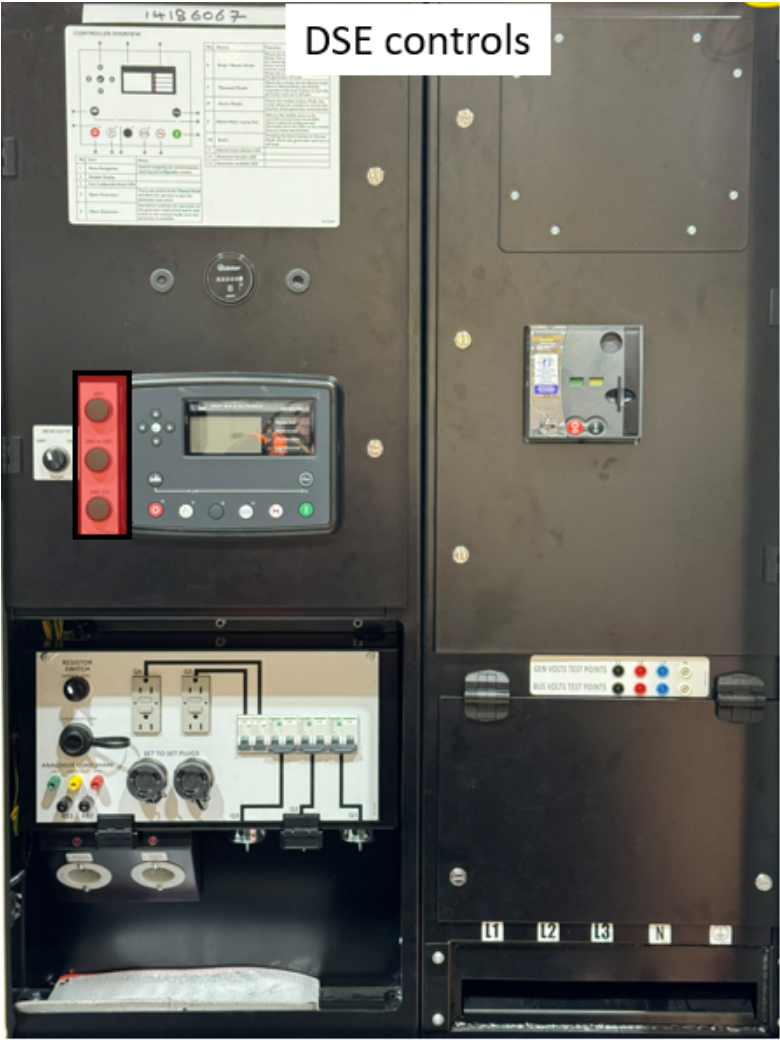
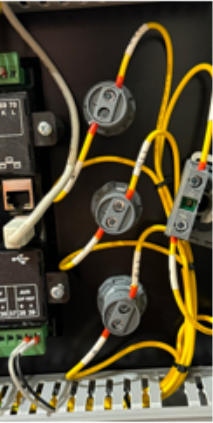
| Location IMG: | <div><div><p>DSE controls</p></div><div></div><div></div></div> |

| Function: | Indication for following AC supply Available<br>i. 120V AC Supply<br>ii. 208V AC Supply<br>iii. 480V AC Supply |
| Location: | Panel Door. |

| <b>Wires &amp; Connectors IMG:</b> | Wire Numbers - 113 and 4<br>Wire Numbers - 110 and 4<br>Wire Numbers -109 and 4 |

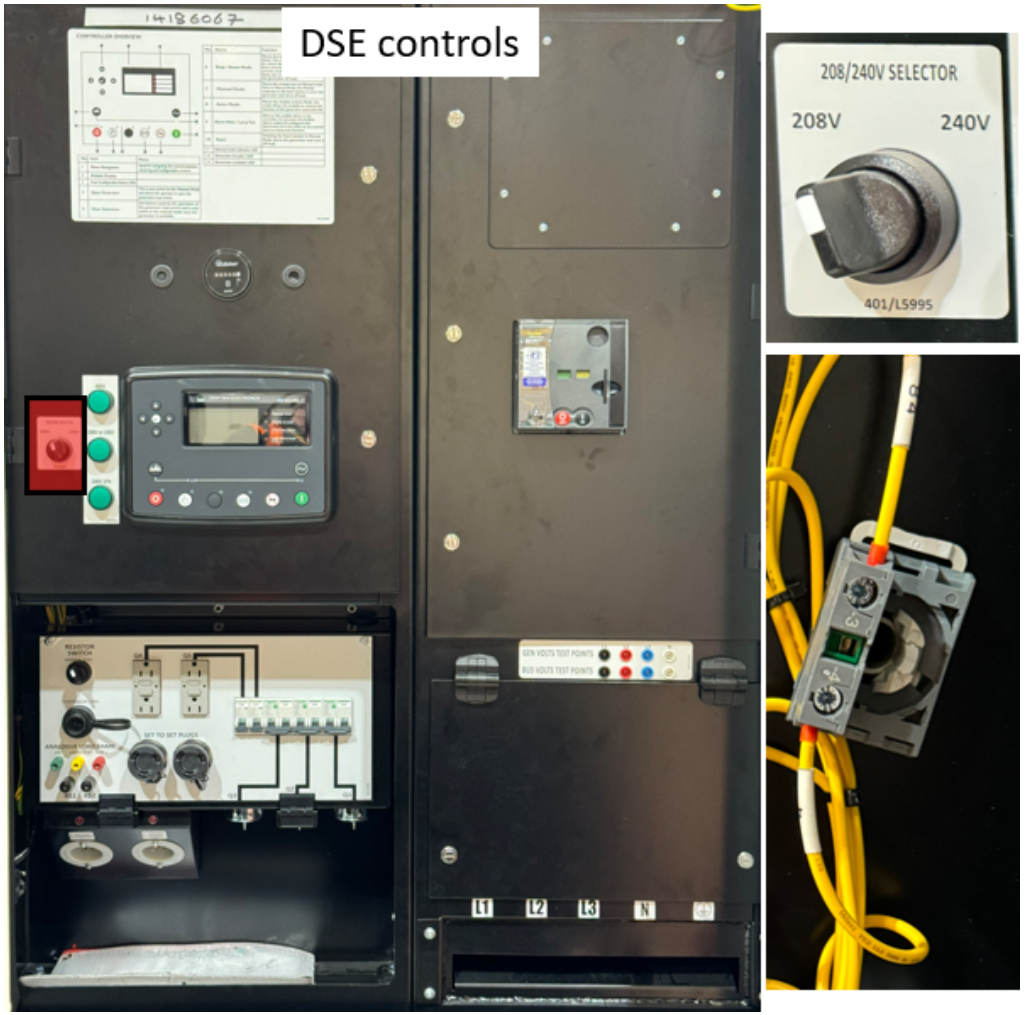
| <b>Function:</b> | On/off switch provided for selecting DSE8610 configuration.<br>Switch On- 240V Selected<br>Switch Off- 208V Selected |
| <b>Location:</b> | Panel Door |

| <b>Wires &amp;<br/>Connect<br/>ors IMG:</b> | Wire Numbers - 4 and 84 |

| <b>Testing:</b> | 1. Turn OFF the supply to panel , make sure all MCBs are in off state, isolator is in OFF state.<br>2. Remove the wire from selector switch and check the continuity in selector switch on position. Change the on/off switch contact block if continuity not found. |

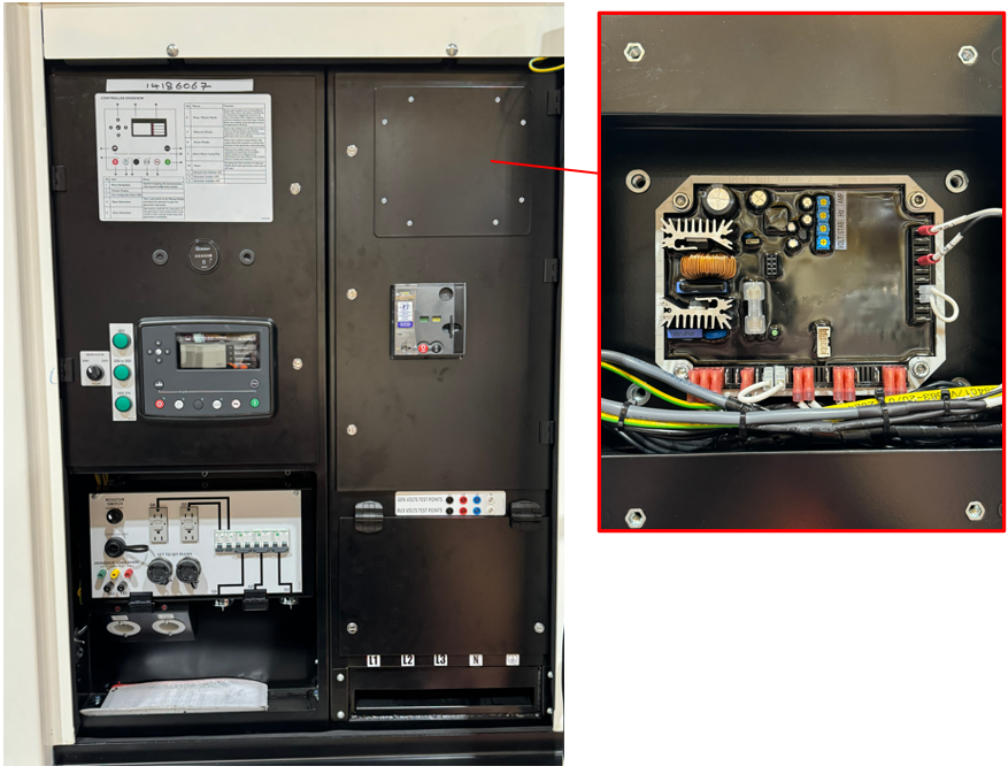
| <b>Location:</b> | Located inside Control panel enclosure, behind a surface mounted panel. |

The image shows a black metal control cabinet. The left door is open, revealing internal components including a digital display, various switches, and a terminal block. A red arrow points from the main image to a larger, red-bordered inset image on the right. This inset shows a close-up of the internal wiring, specifically a terminal block with multiple colored wires (yellow, green, blue, red) connected to it.                           |     |   |     |   |     |   |     |   |     |   |     |   |     |   |     |   |     |   |     |    |
| Signal: | As per rated voltage Set in controller | | | | | | | | | | | | | | | | | | | | |
| Wires &<br>Connect<br>ors IMG: | <p><b><u>X2 Alternator AVR connector</u></b></p> <p><b><u>Wire Numbers - Terminal Number</u></b></p>

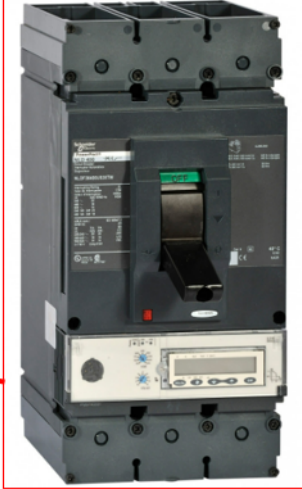
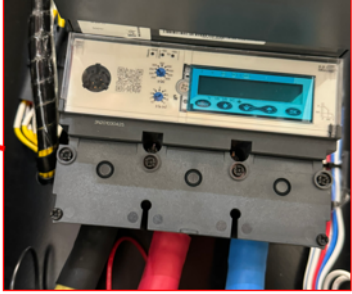
| <b>Function:</b> | MCCB is used inline in between Alternator and load which interrupts during any power fault like over load and shortcircuit or any Generator faults |
| <b>Location:</b> | Located inside Control panel breaker box mid Section |

| <b>Wires &amp; Connectors IMG:</b> | <b><u>Cable Numbers</u></b><br>L1 - Black<br>L2 - Red<br>L3 - Blue<br><br>Phase power cable 120 Sq mm |

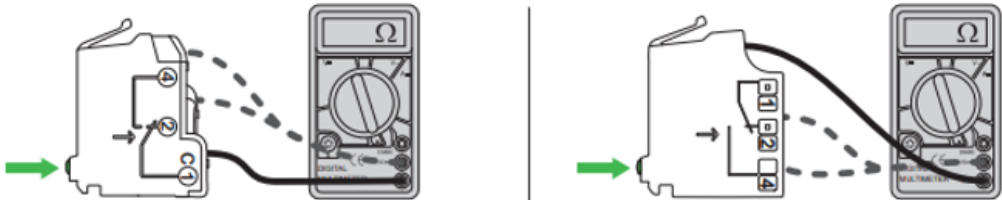
<p><b>Standard and Low-Level Contacts</b><br/>Standard and low-level contacts are the common point changeover type.</p>

<table><tr> <th>Name</th><th>Definition</th></tr><tr> <td>SD auxiliary contact</td><td>Trip indication: The SD contact indicates that the circuit breaker has tripped due to: <ul style="list-style-type: none"> <li>Long-time protection</li> <li>Short-time protection</li> <li>Ground-fault protection</li> <li>Earth-leakage protection (trip by Micrologic 4 or 7 trip unit, or by Vigi module)</li> <li>Operation of the MX or MN voltage releases</li> <li>Operation of the push-to-trip button</li> <li>Connecting/Disconnecting the circuit breaker</li> <li>Manually opening the motor mechanism</li> </ul> </td></tr></table>

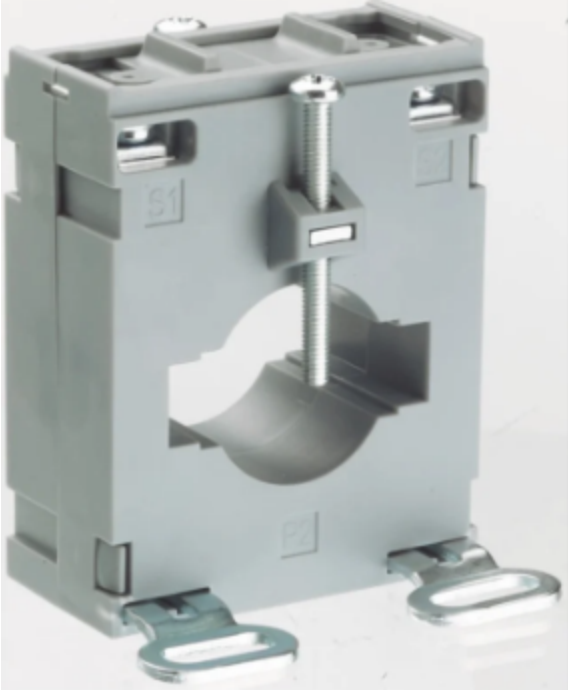
Location  
IMG:

| <b>Location:</b> | Mounted inside the AC section of the controls enclosure above the MCCB. |

| <b>Wires &amp; Connectors IMG:</b> | Wire Numbers - 29,30,31 and 32 |

| <b>Testing:</b> | <p>For non function of one or all.</p> <p>1. Check connections on the CT's and Controller.<br/>Check for physical damage to casing and cable that passes through.<br/>Check continuity of each wire 29, 30, 31 from CT to controller and check the common ground wire 32 from CT to controller and ground (earth).<br/>Testing resistance on CT terminals S1 and S2 will only test the Secondary circuit which measure at 0.3 Ohm.</p> |

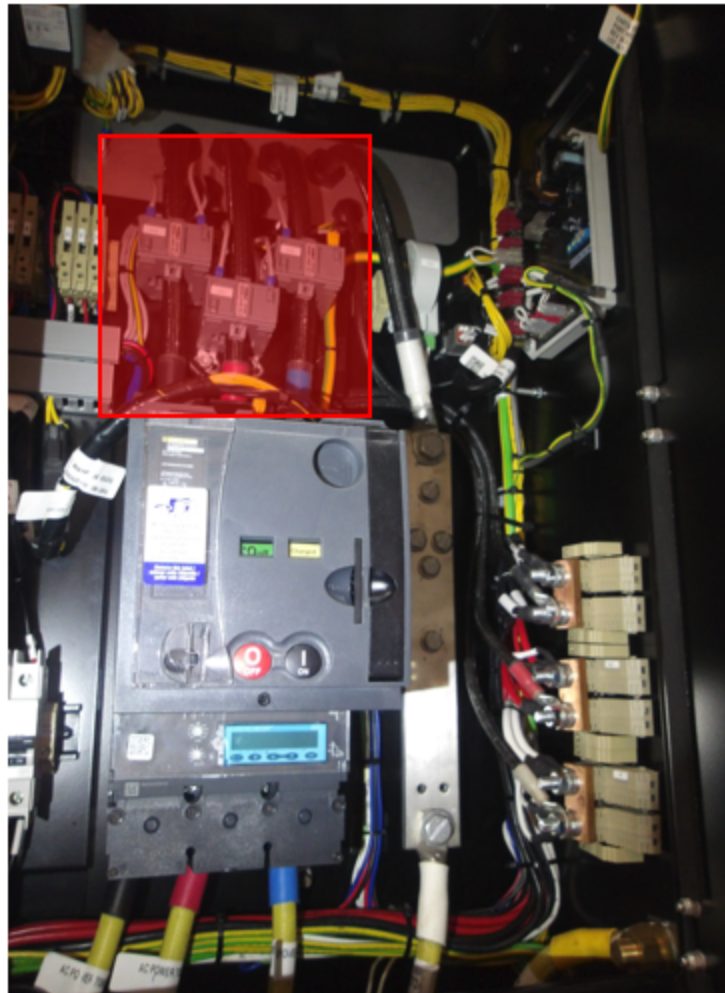
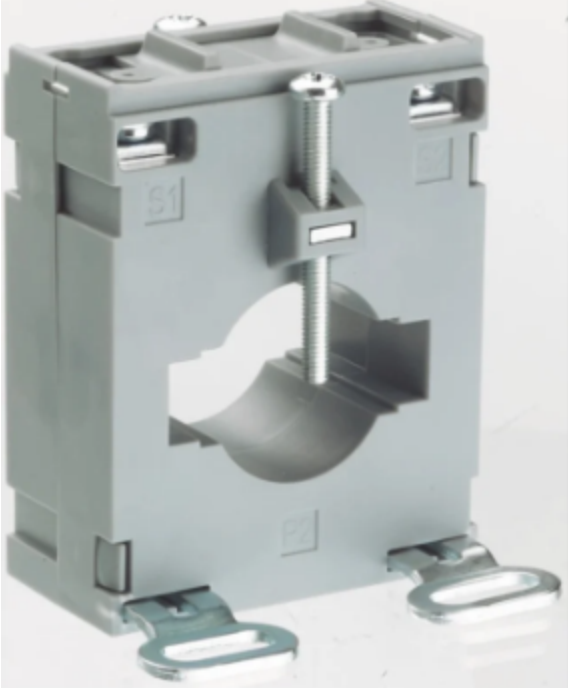
Location  
IMG:

| <b>Location:</b> | Mounted inside the AC section of the controls enclosure above the ACB. |

| <b>Wires &amp; Connectors IMG:</b> | Wire Numbers - 29,30,31 and 32 |

| <b>Testing:</b> | <p>For non function of one or all.</p> <p>1. Check connections on the CT's and Controller.<br/>Check for physical damage to casing and cable that passes through.<br/>Check continuity of each wire 29, 30, 31 from CT to controller and check the common ground wire 32 from CT to controller and ground (earth).<br/>Testing resistance on CT terminals S1 and S2 will only test the Secondary circuit which measure at 0.3 Ohm.</p> |

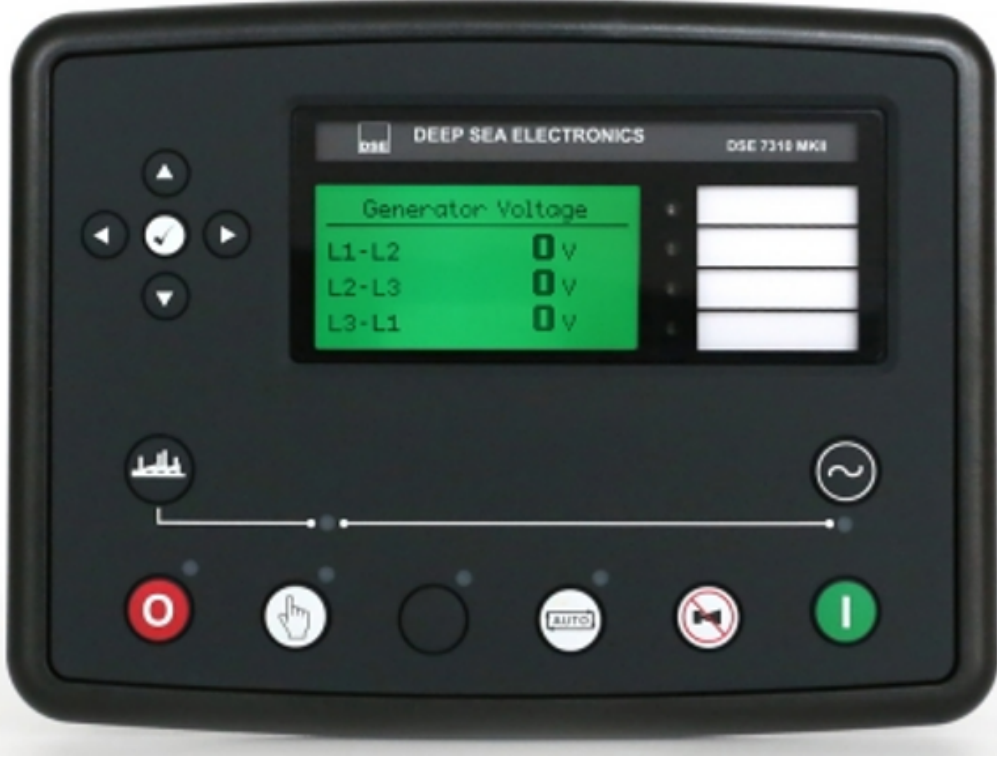
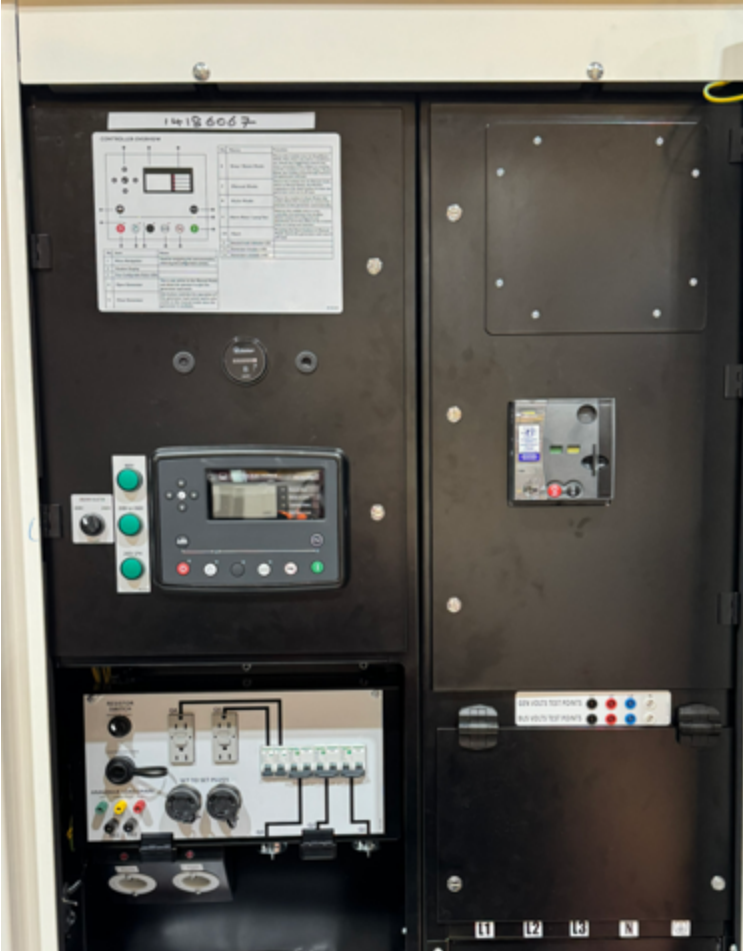
| <b>Component:</b> | <b>DSE 7310MKII GENERATOR CONTROLLER</b> |

| <b>Function:</b> | Main generator control unit |

| <b>Location:</b> | Located on Control panel door. |

| <b>Location</b><br><b>IMG:</b> | A black electrical control cabinet is shown. The left door is open, revealing internal components. On the left door, there is a white label with a circuit diagram and text. Below the label are two green push buttons and a small digital display. The right door is closed and has a small rectangular panel with a switch and indicator lights. At the bottom of the cabinet, there is a terminal block with various colored wires connected to it. The cabinet is mounted on a wall. |

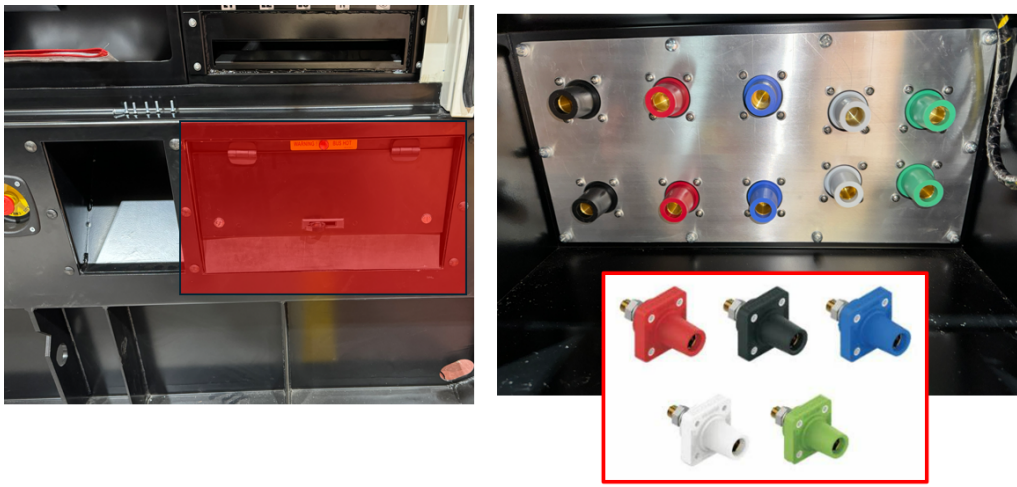
| <b>Function:</b> | Allows quick main power output connection | |
| <b>Location:</b> | Camlock Box | |
| <b>Wires &amp; Connectors IMG:</b> | <u>Cables</u><br>Black - L1<br>Red - L2 | |

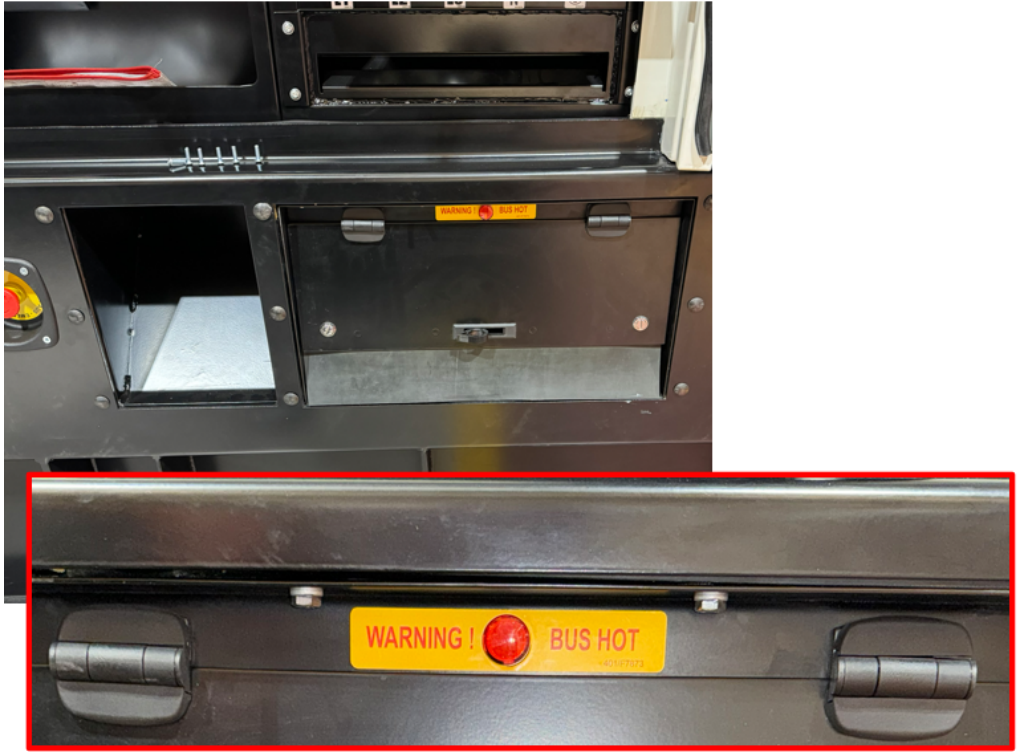
| <b>Function:</b> | Shows output terminal state |
| <b>Location:</b> | Camlock Box |

| <b>Wires &amp;<br/>Connect<br/>ors IMG:</b> | Wire Numbers<br>4 and 112 |

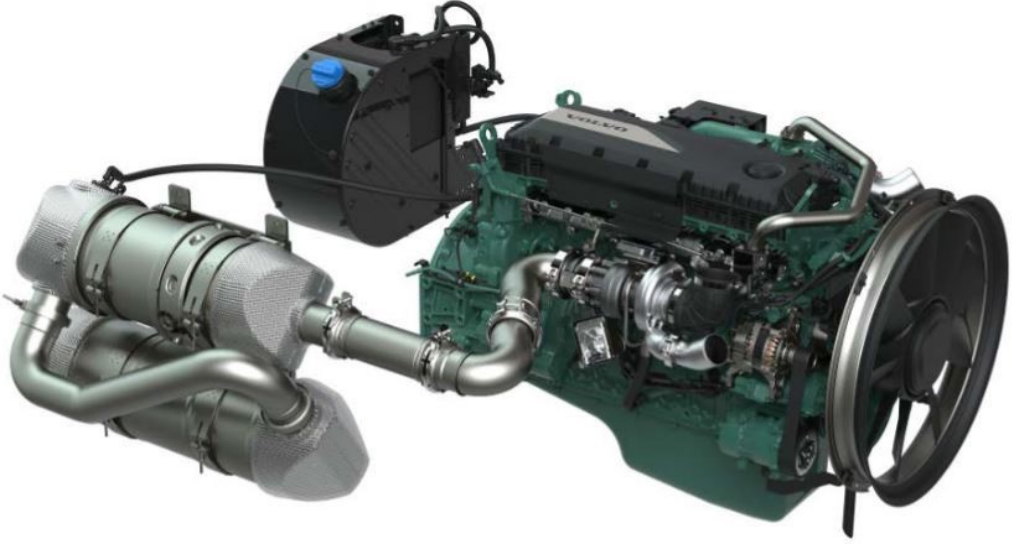
| <b>Function:</b> | Utilised as the Prime mover in a Genset.<br>Other common names:<br>Engine / Combustion engine<br><br>Used as the source of torque or rotational kinetic energy that spins the rotating assembly within the coupled alternator. |
| <b>Location:</b> | Inside genset canopy, between the cooling pack and alternator. |

| <b>Signal:</b> | Prime Mover electronic control = 12Vdc<br><br>Prime Mover combustion fuel = EN590 Diesel or Alternative Fuels<br><br>Prime Mover communication = SAE J1939 |

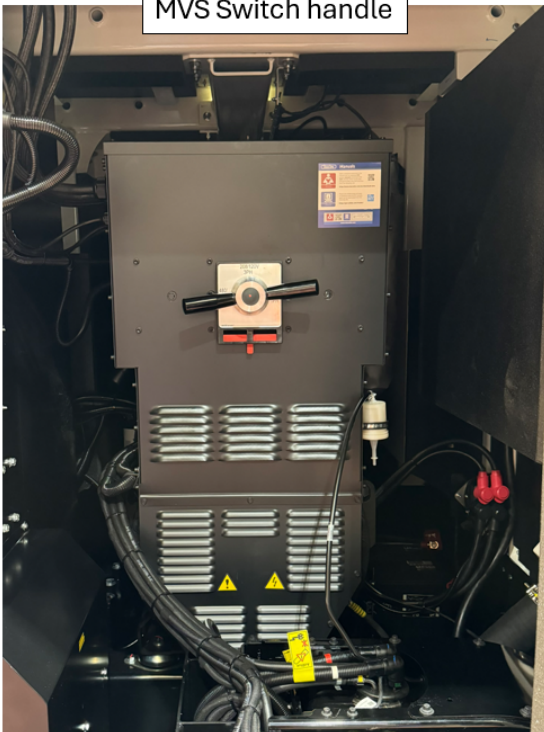
| <b>Function:</b> | To change output voltage or phase types from the genset alternator. |
| <b>Location:</b> | Inside generator canopy, located at the rear of the alternators control box which is directly mounted to the alternators top side. Also accessible from the genset rear door. |

| <b>Location<br/>IMG:</b> | <div><div>MVS Switch handle</div><div>MVS Switching</div><div>MVS switch position feedback to controls.</div></div> |
| <b>Wires &amp;<br/>Connect<br/>ors IMG:</b> | <p><u>Cables</u></p> <p>Main contacts:<br/>3 phase Vac<br/>L1 - ALT Stud 1 - Select Sw terminal 1<br/>L2 - ALT Stud 5 - Select Sw terminal 11<br/>L3 - ALT Stud 9 - Select Sw terminal 19<br/>N -ALT Stud 4 - Select Sw terminal 26</p> <p>Single phase (3 wire) Vac<br/>1L1 - ALT Stud 3 - Select Sw terminal 2<br/>1L2 - ALT Stud 7 - Select Sw terminal 10<br/>N - ALT stud 8 - Select Sw terminal 26</p> |
