# **9819-5500-2.3.2: G220RS G400RS G625RS T4F DC Help Files - English (en\_GB)**

## **USER MANUAL**

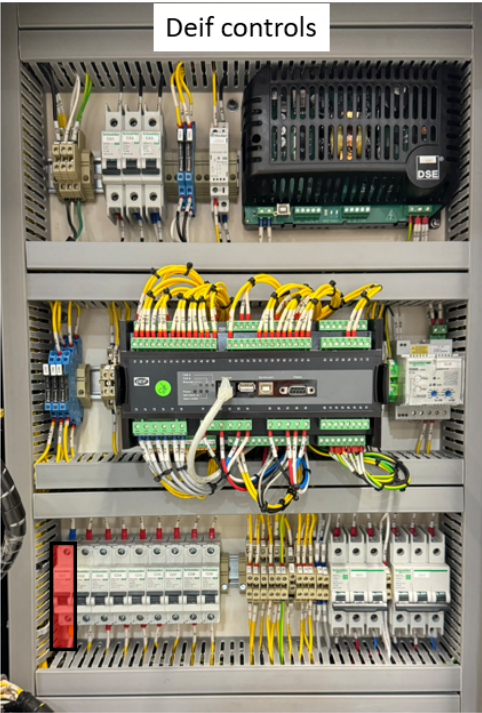
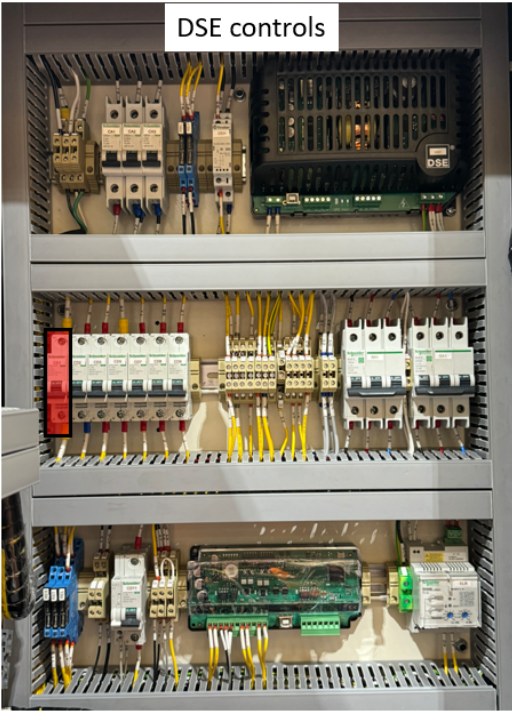
| Location IMG: | <div><div>Deif controls</div></div> <div><div>DSE controls</div></div> | |

| Function: | CD1- 2A Protection/Controls the controller DC supply | |
| Location: | MCB located inside the control panel | |

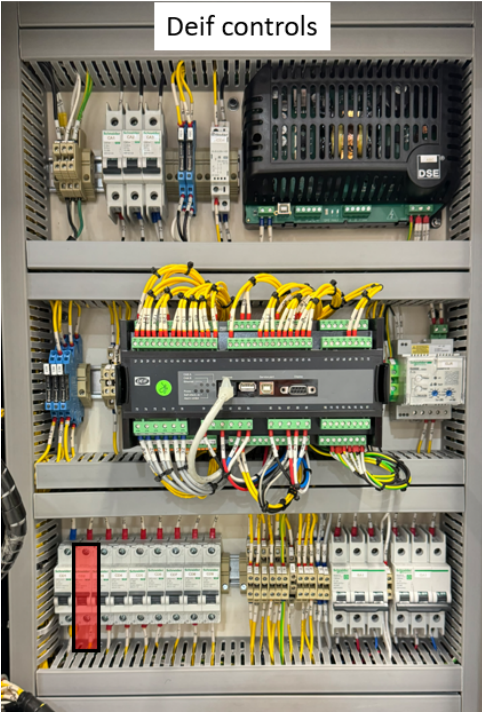
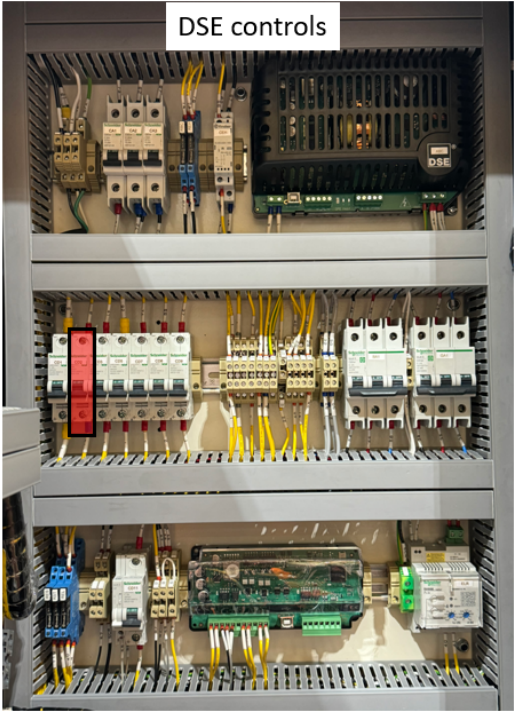
| Location IMG: | <div><div>Deif controls</div><div>DSE controls</div></div> |

| Function: | CD2 - 6A Protection/Controllers the E-Stop DC supply |
| Location: | MCB located inside the control panel |

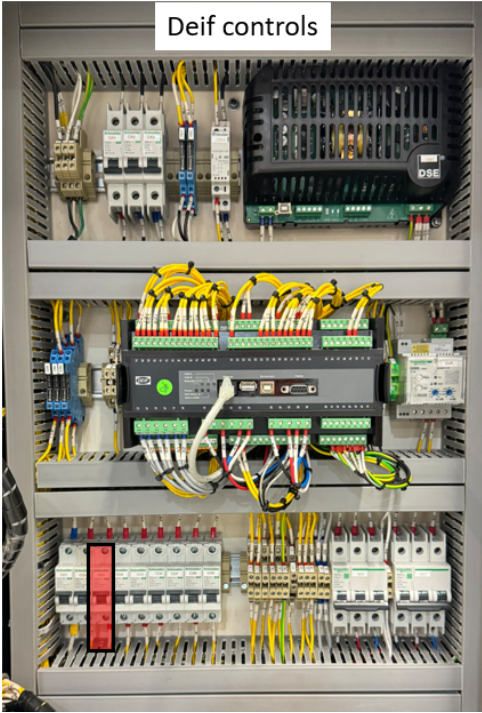
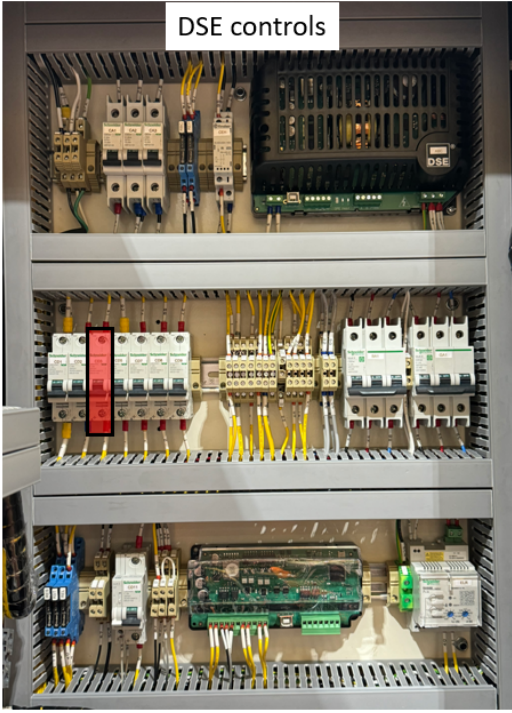
| <b>Location IMG:</b> | <div><div><p>Deif controls</p></div><div><p>DSE controls</p></div></div> |

| <b>Function:</b> | CD3 - 2A Protection/Controls the Shunt Trip DC supply |
| <b>Location:</b> | MCB located inside the control panel |

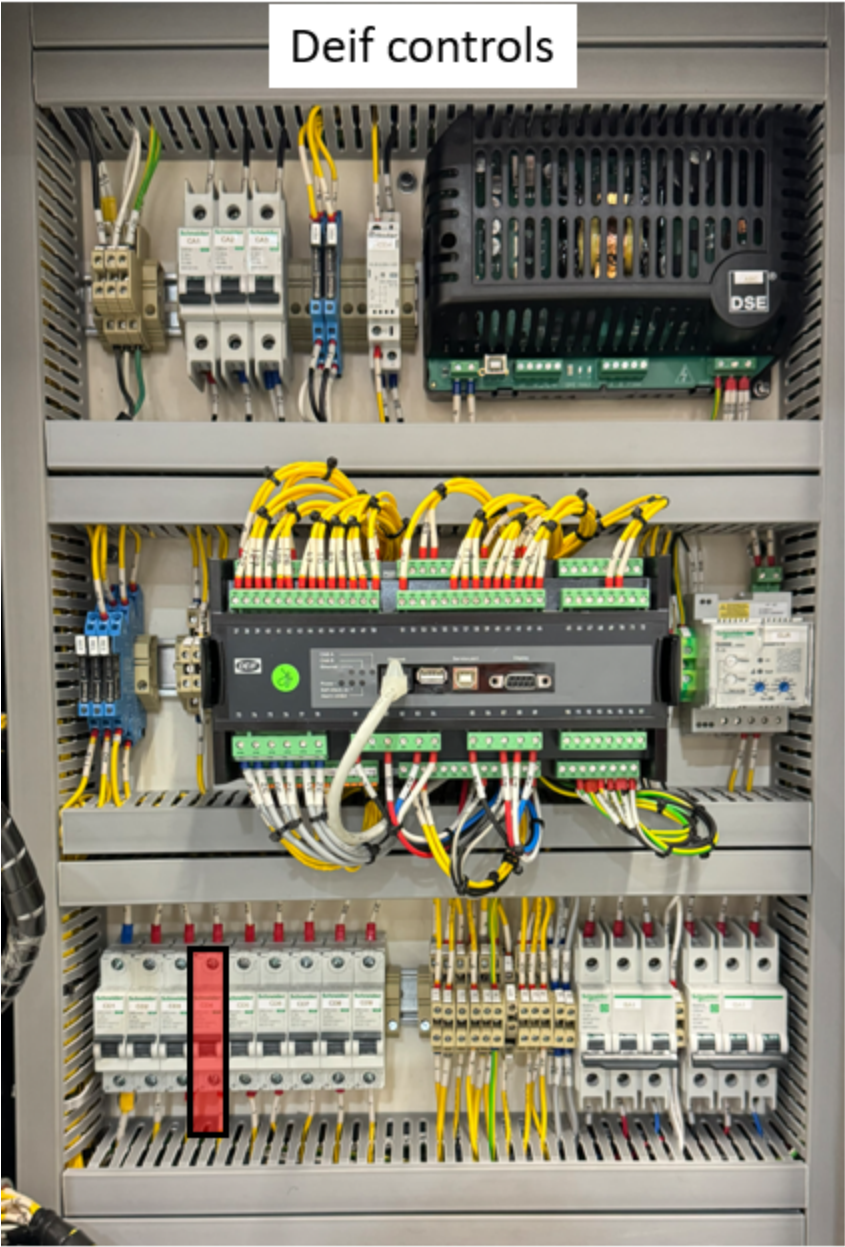
| <b>Location</b><br><b>IMG:</b> | <div>Deif controls</div> |

| <b>Function:</b> | CD4 - 4A Deif TDU Display DC Supply 1P MCB |
| <b>Location:</b> | MCB located inside the control panel |

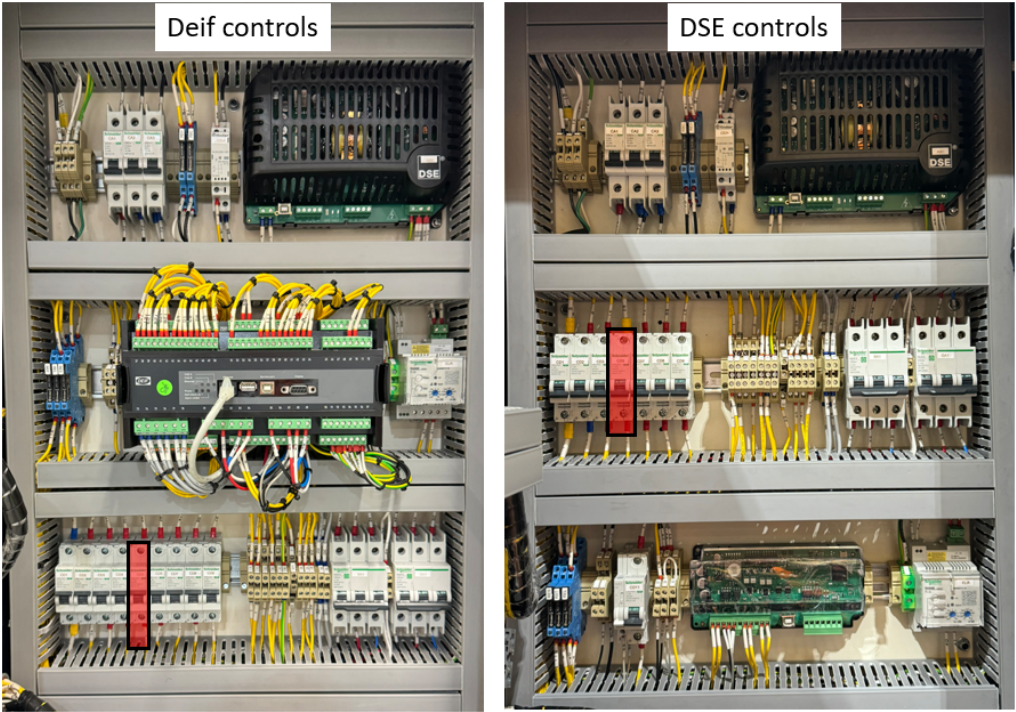
| <b>Location IMG:</b> | |

| <b>Function:</b> | CD5 - 10A CB Control Circuit DC Output |
| <b>Location:</b> | MCB located inside the control panel |

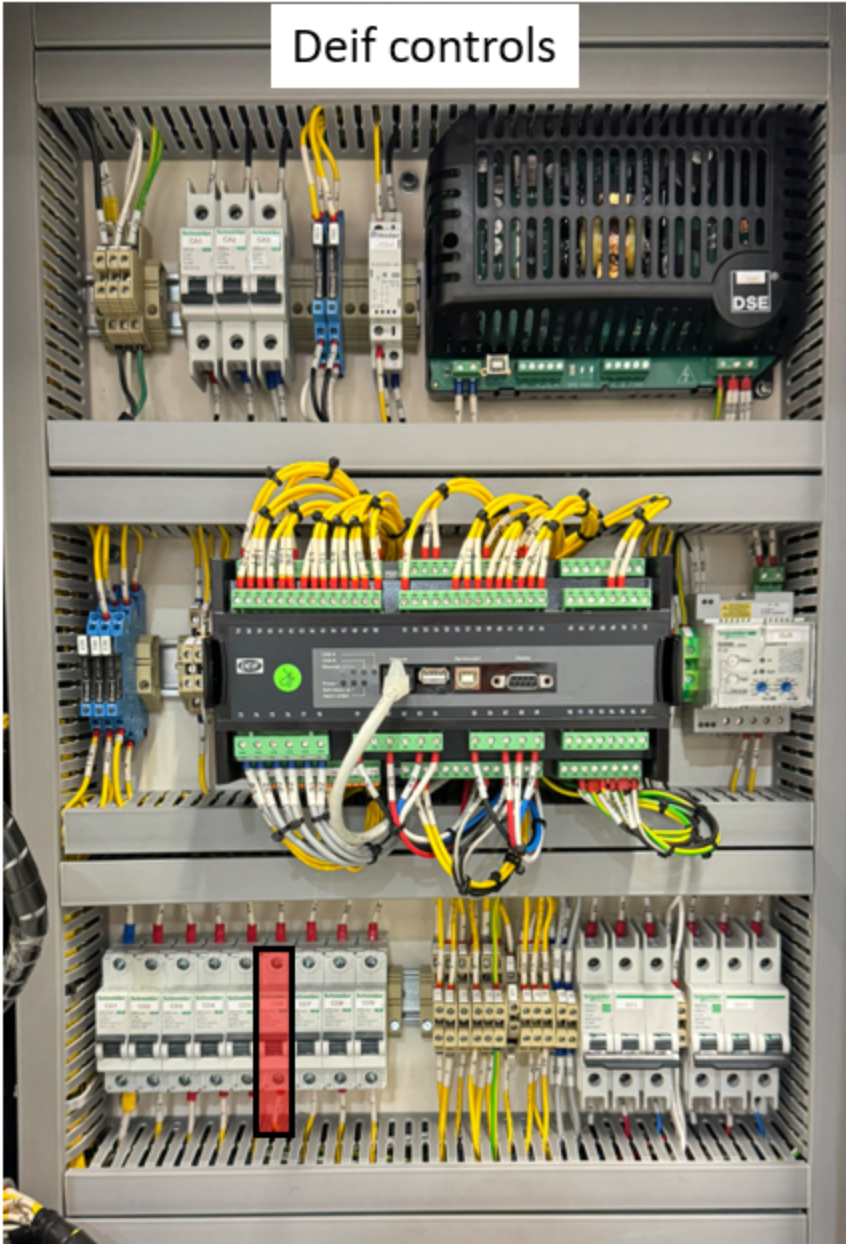
| Location IMG: | <div>Deif controls</div> |

| Function: | CD6 - 2A AVR DVC550 DC Output |
| Location: | MCB located inside the control panel |

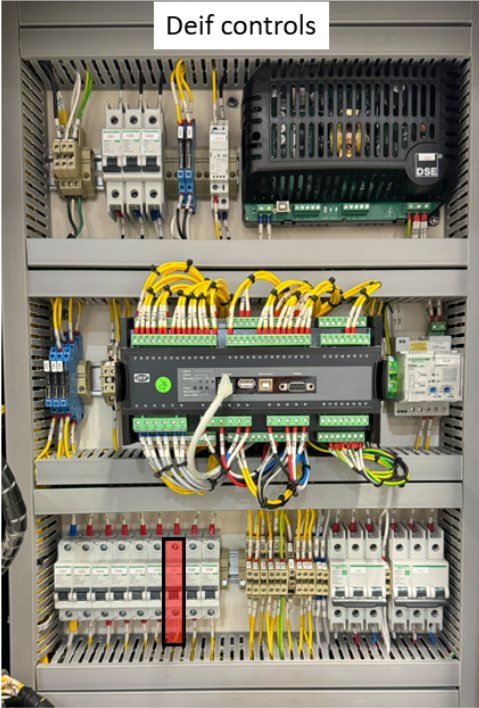
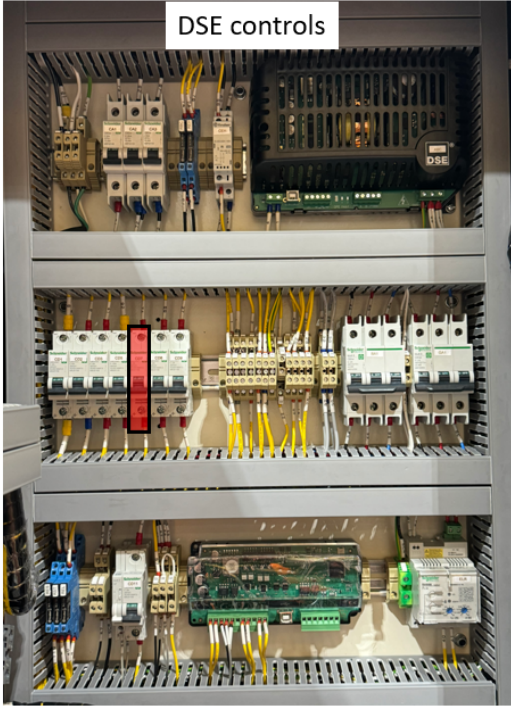
| Location IMG: | <div><div>Deif controls</div></div> <div><div>DSE controls</div></div> | |

| Function: | CD7 Controls the supply to the Auxiliary supply LEDs. | |
| Location: | MCB located inside the control panel | |

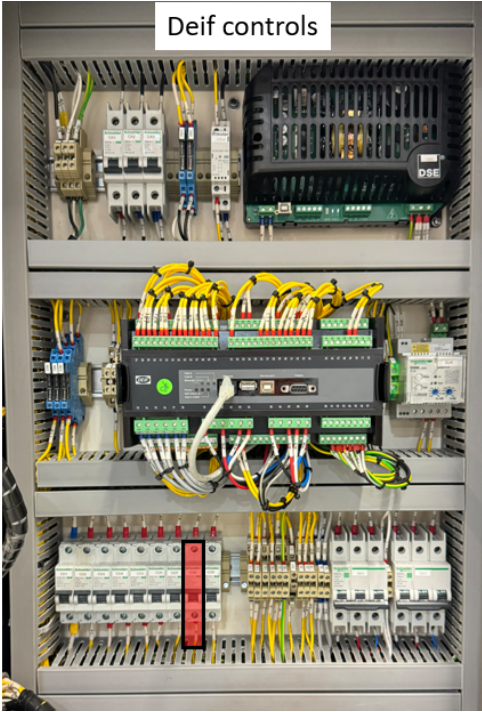
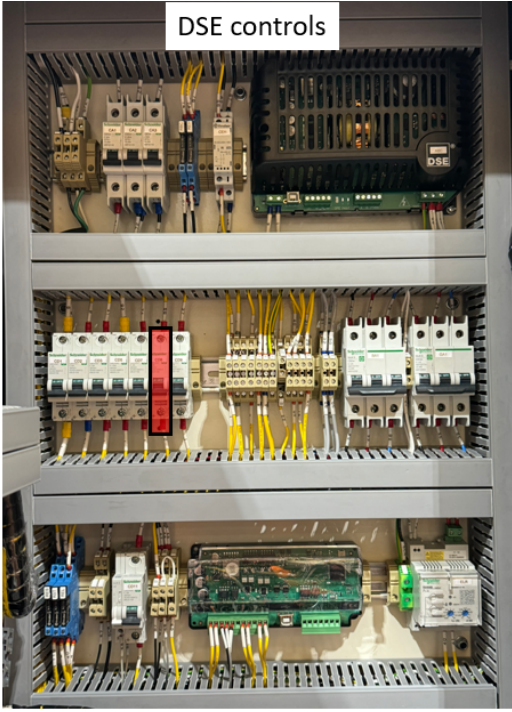
| <b>Function:</b> | CD8 - 2A Protection/Controls the CHE DC supply |

| <b>Location:</b> | MCB located inside the control panel | |

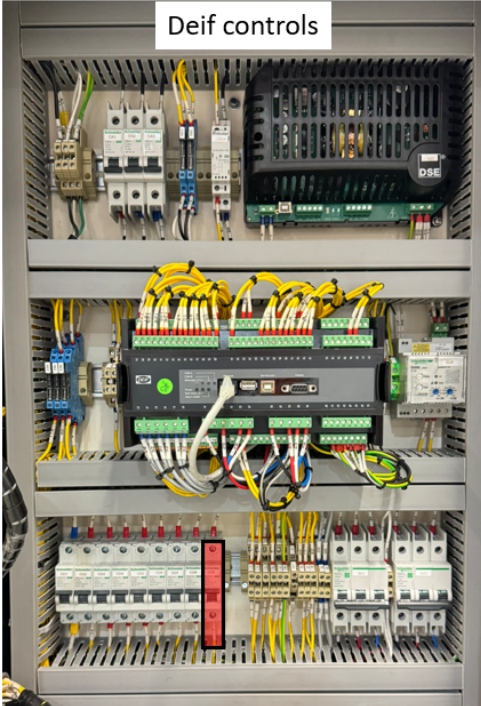
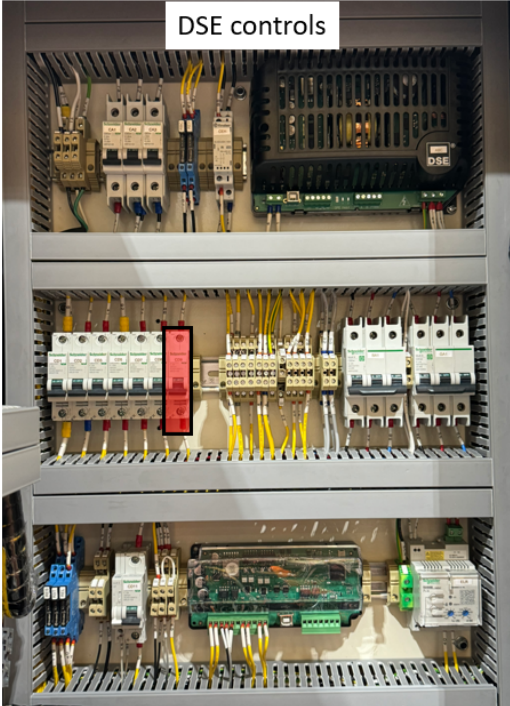
| <b>Function:</b> | CD9 - 2A Protection/Controls the ELR DC supply |
| <b>Location:</b> | MCB located inside the control panel |

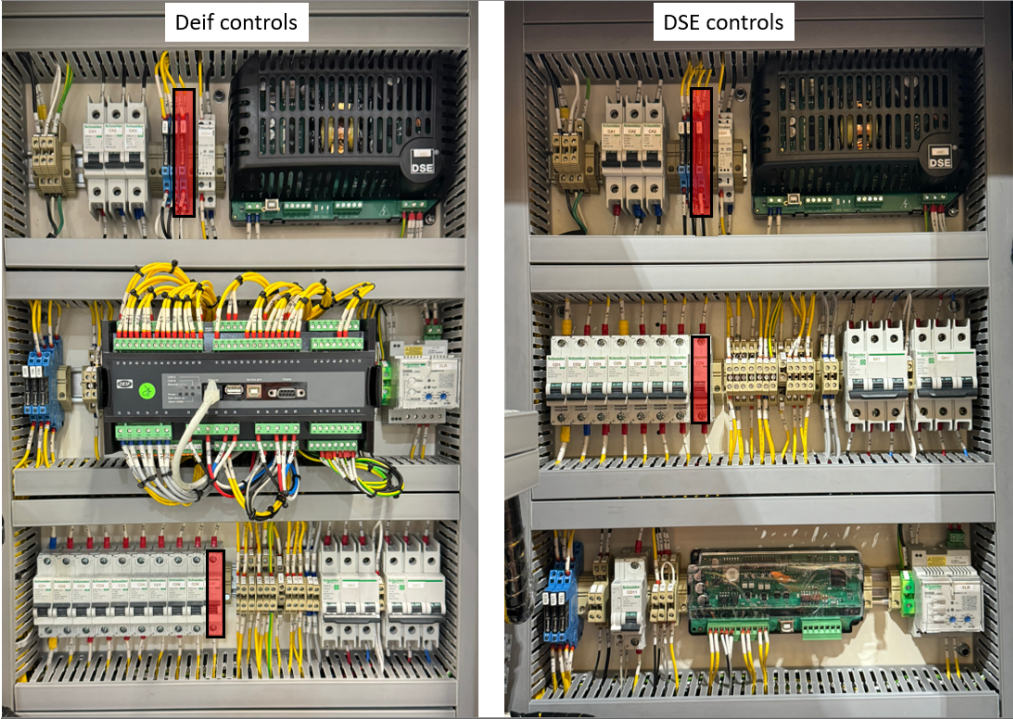
| <b>Function:</b> | CD10 - 6A Protection/Controls the RAS Contacts DC supply (Optional) |
| <b>Location:</b> | MCB located inside the control panel |

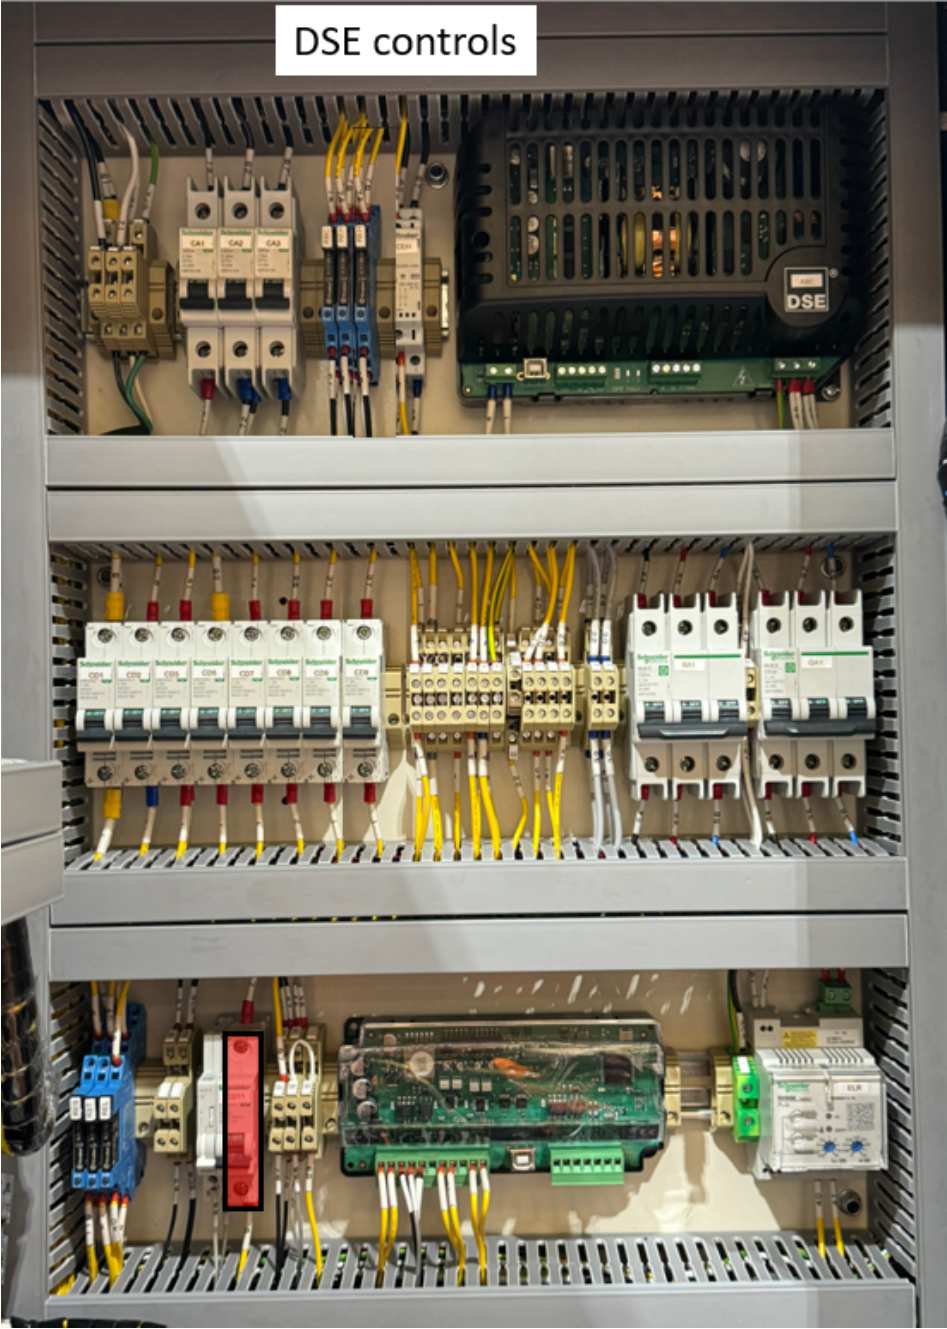
| <b>Location<br/>IMG:</b> | <div><div>DSE controls</div></div> |

| <b>Function:</b> | CD11 - 2A Protection/Controls the DSE 123 DC supply |
| <b>Location:</b> | MCB located inside the control panel |

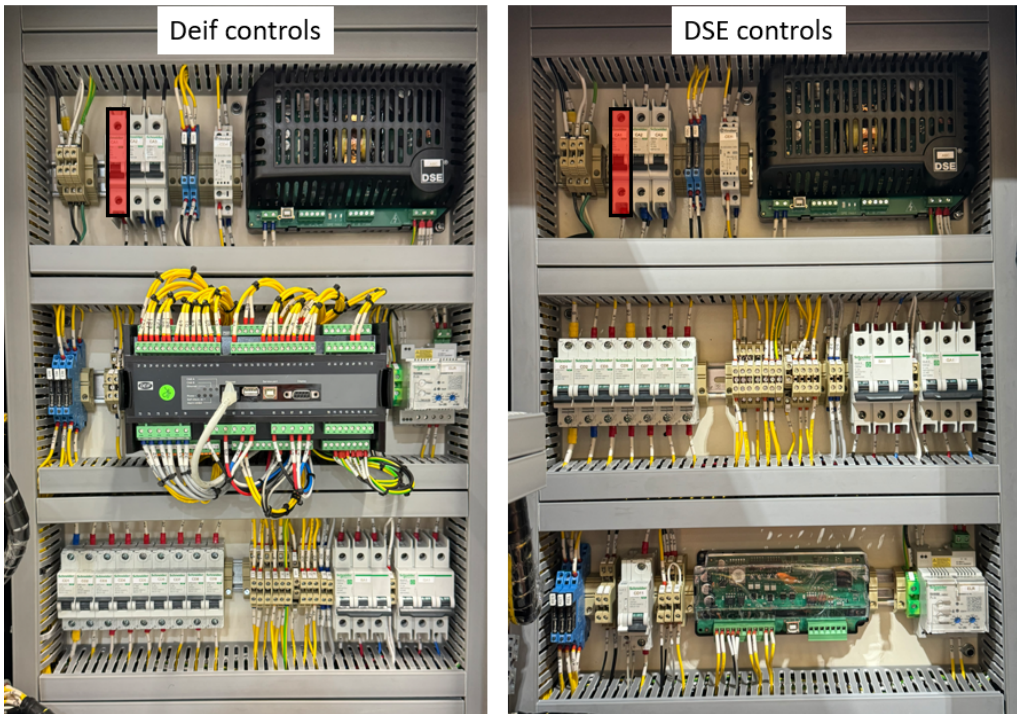
| <b>Location IMG:</b> | |

| <b>Function:</b> | CA1 - 6A Protection/Controls the Battery Charger AC input supply |
| <b>Location:</b> | MCB located inside the control panel |

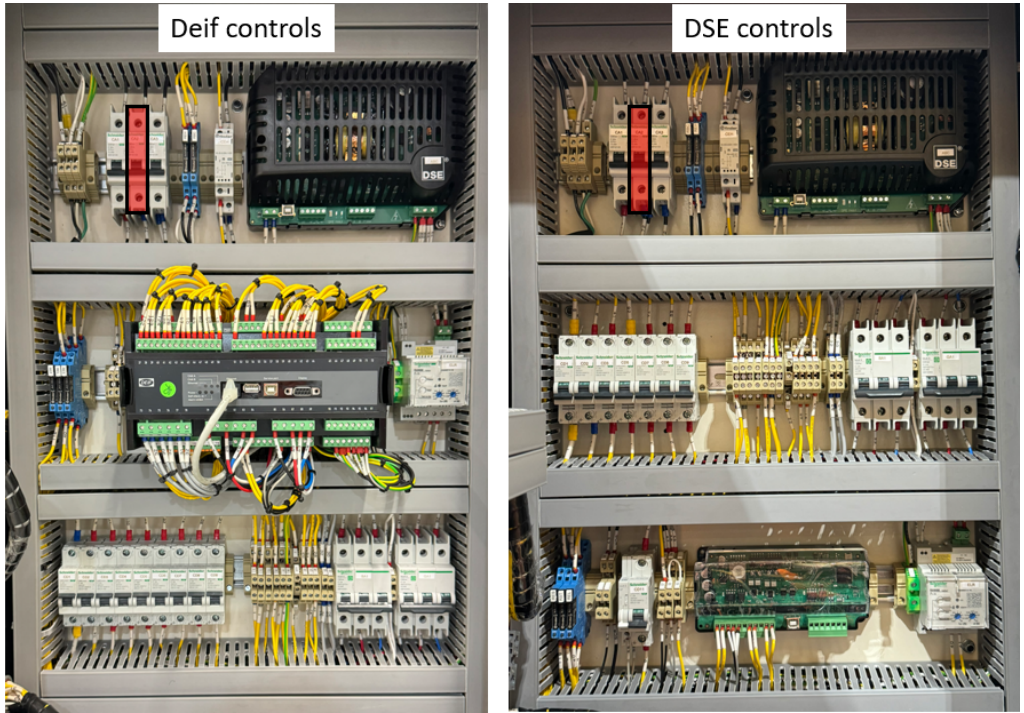
| <b>Location IMG:</b> | |

| <b>Function:</b> | CA2 - 20A Protection/Controls the Engine Heater AC supply |
| <b>Location:</b> | MCB located inside the control panel |

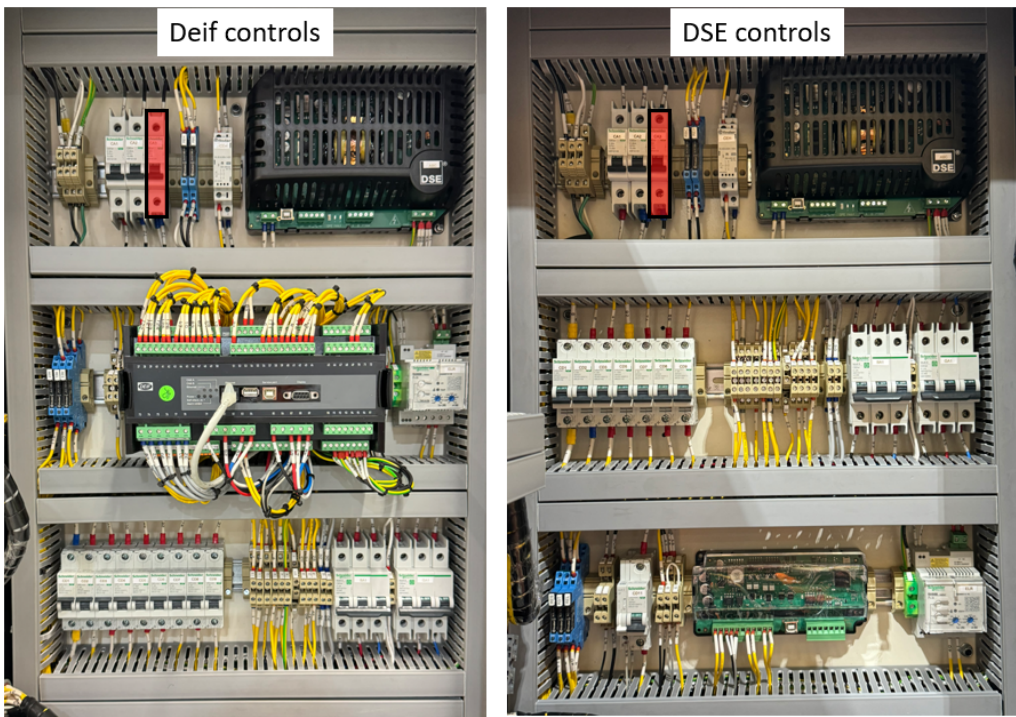
| <b>Location IMG:</b> | |

| <b>Function:</b> | CA3 - 6A Protection/Controls the Alternator Heater AC supply |
| <b>Location:</b> | MCB located inside the control panel |

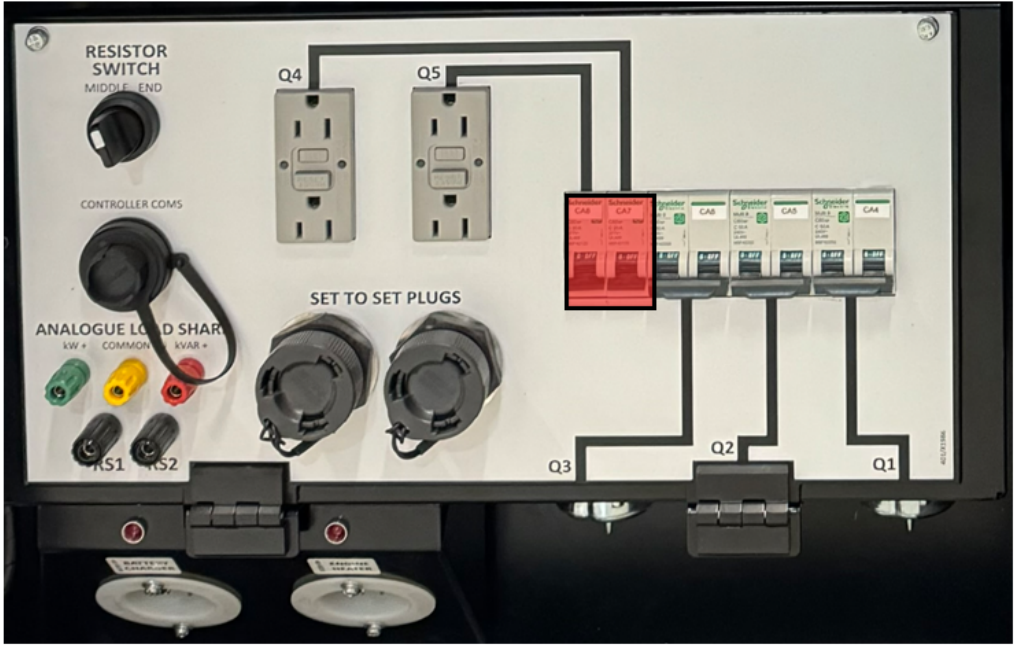
| <b>Function:</b> | CA7&CA8- 15A Protection/Controls the GFCI socket AC supply. |
| <b>Location:</b> | MCB located inside the control panel. |

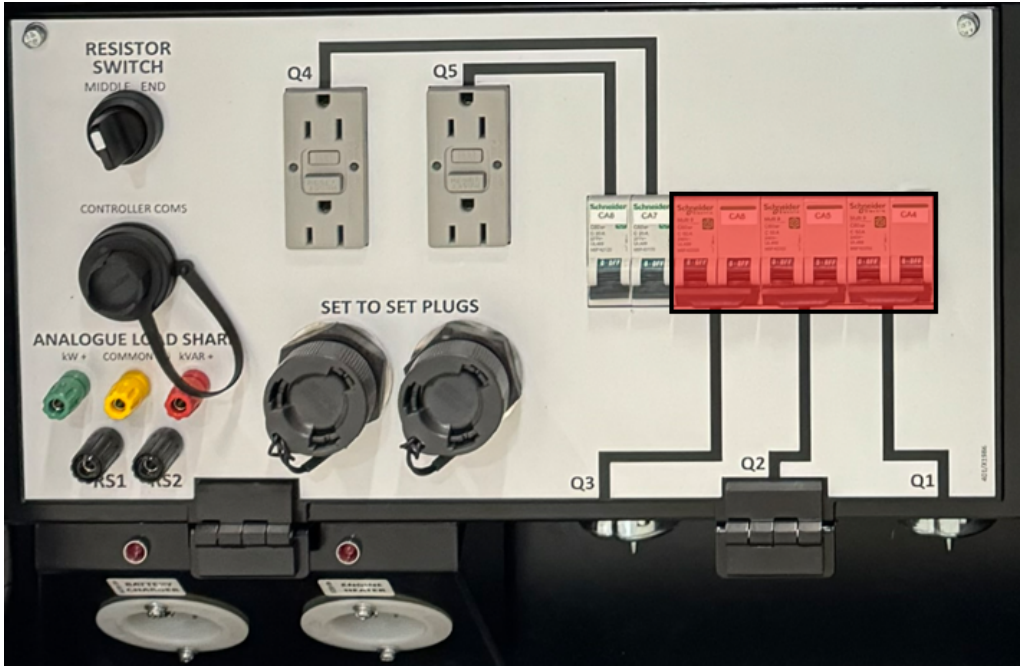
| <b>Location IMG:</b> | |

| <b>Function:</b> | CA4, CA5, CA6 - 50A Twist lock Connector supply |
| <b>Location:</b> | MCB located inside the control panel |

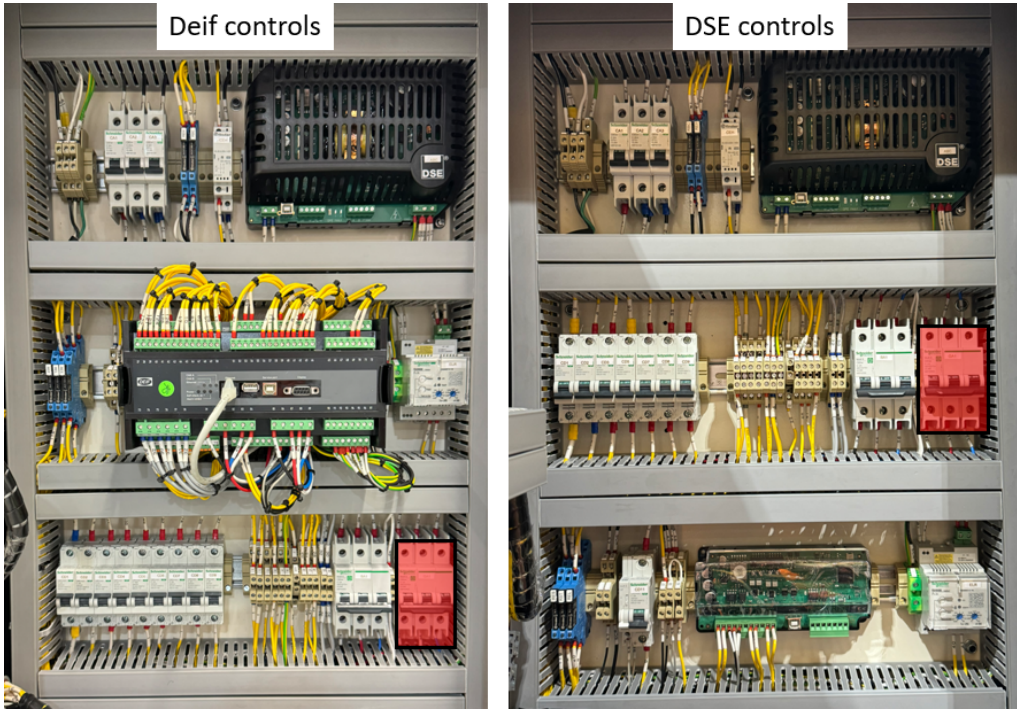
| <b>Location IMG:</b> | |

| <b>Function:</b> | GA1 - 2A Gen Voltage sensing |
| <b>Location:</b> | MCB located inside the control panel |

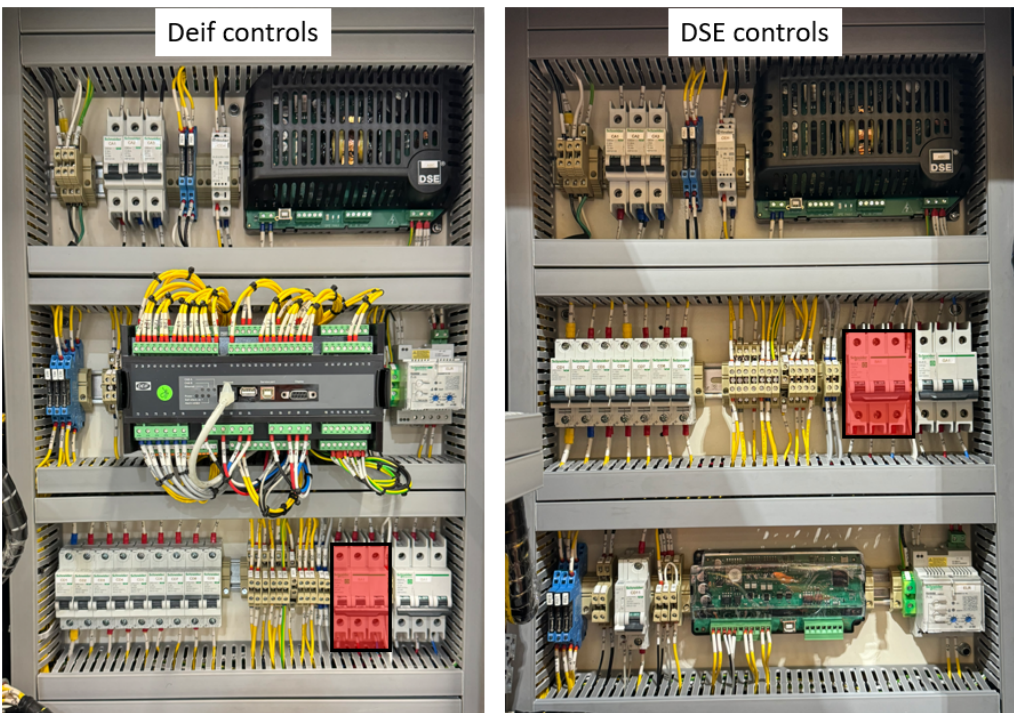
| <b>Location IMG:</b> | | |

| <b>Function:</b> | BA1 - Bus Voltage sensing. | |
| <b>Location:</b> | MCB located inside the control panel. | |

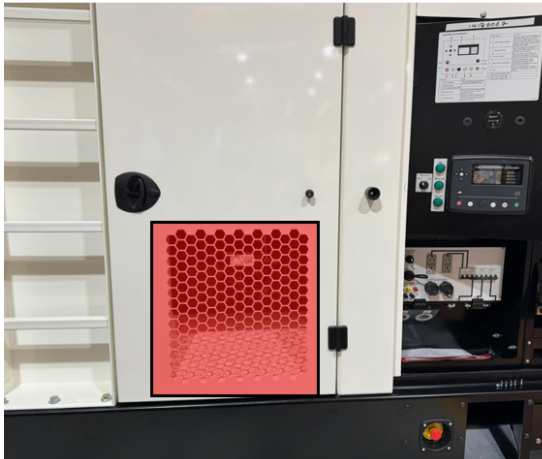
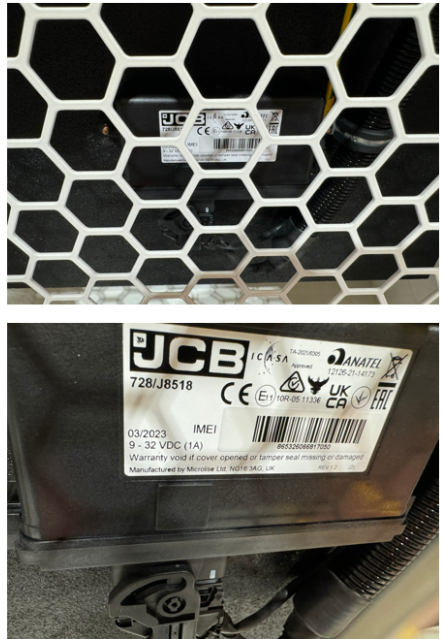
| <b>Location IMG:</b> | |

| <b>Function:</b> | Telematics Device to transmit machine live data to server |
| <b>Location:</b> | Canopy door |

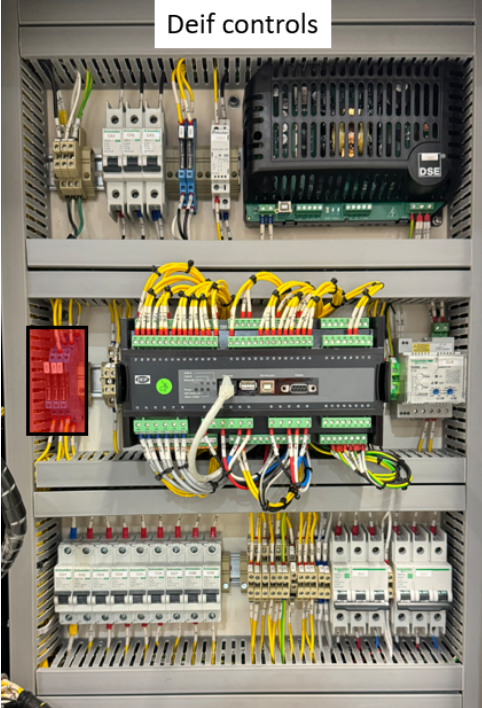
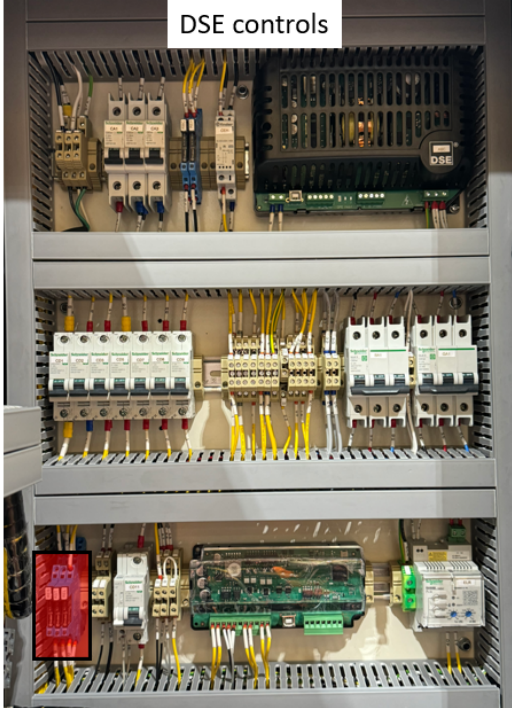
| <b>Function:</b> | REL - Earth leakage Relay<br>RES - Emergency stop Relay<br>RES - Shunt Trip |
| <b>Location:</b> | Located inside the control panel. |

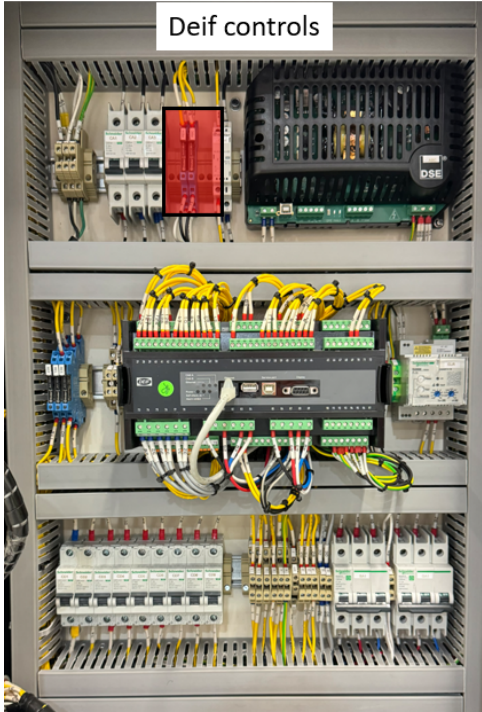
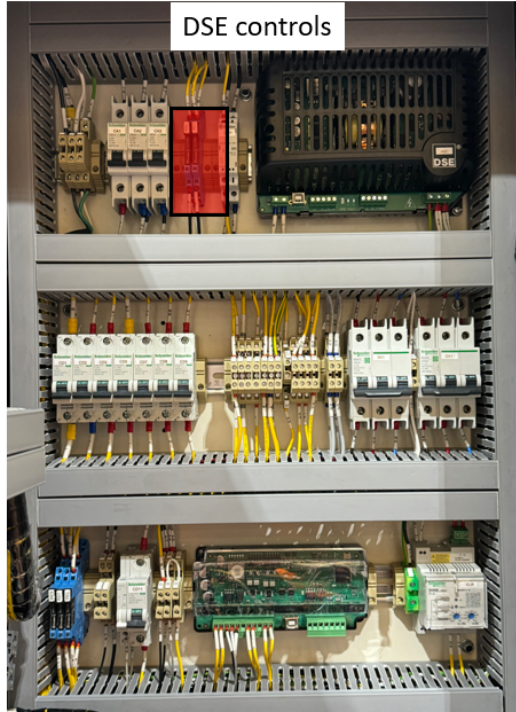
| <b>Function:</b> | RBC - Battery Charger option Relay<br>REH - Engine Heater option Relay |
| <b>Location:</b> | Relay is located inside the control panel |

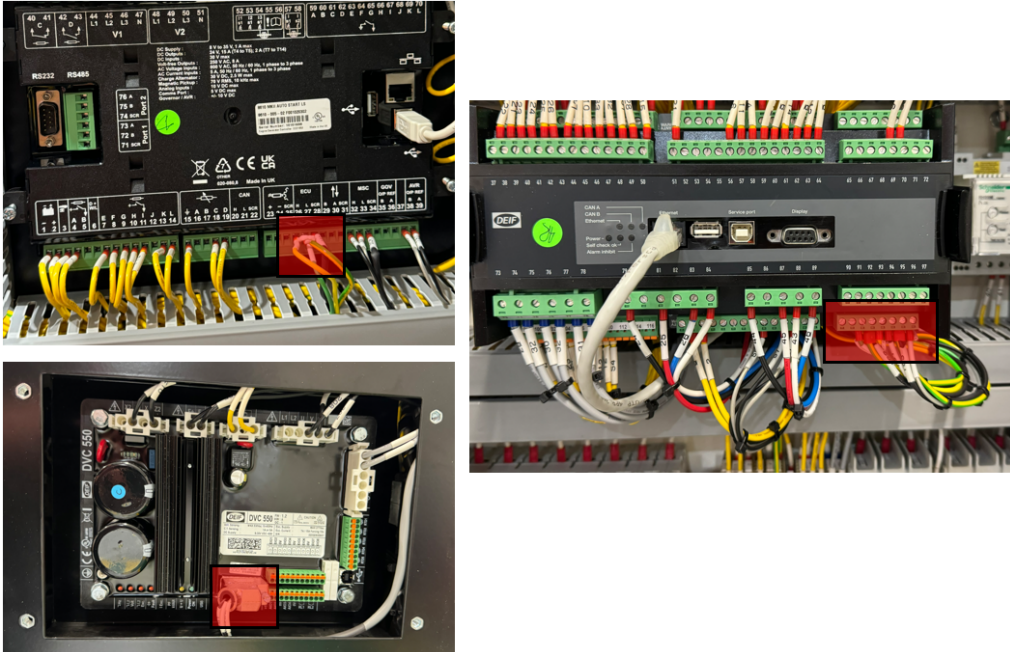
| <b>Function:</b> | 120 Ohm resistor required at the both end of CAN cable to match the characterstic impedance of the cable where CAN communication required between nos of module. |
| <b>Location:</b> | Inside Panel - at rear of DSE controller, on bottom right of AGC4 and in plug of DVC550 CAN connector. |

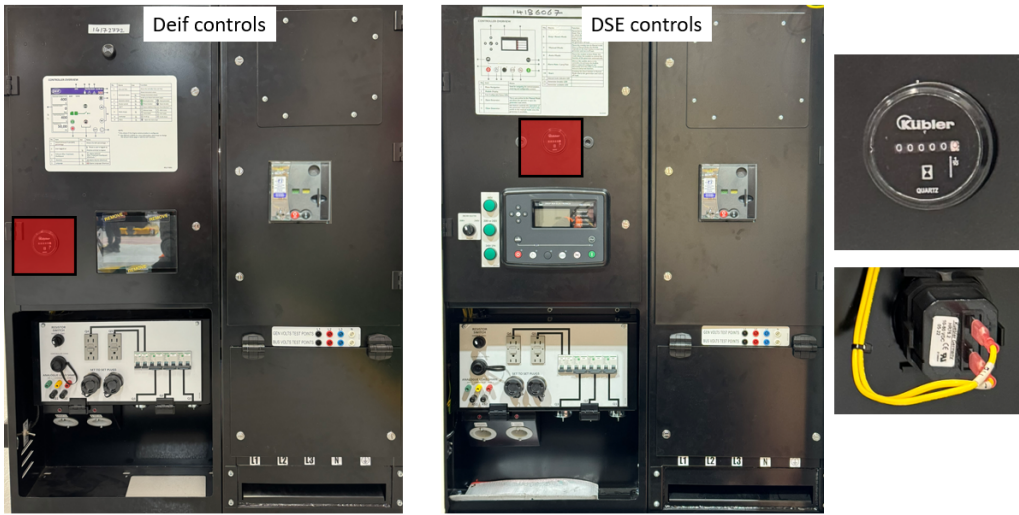
| <b>Location IMG:</b> | | | |

| <b>Function:</b> | Hour Counter is a measuring instrument to measure the Generator running hour. | | |
| <b>Location:</b> | Panel Door. | | |

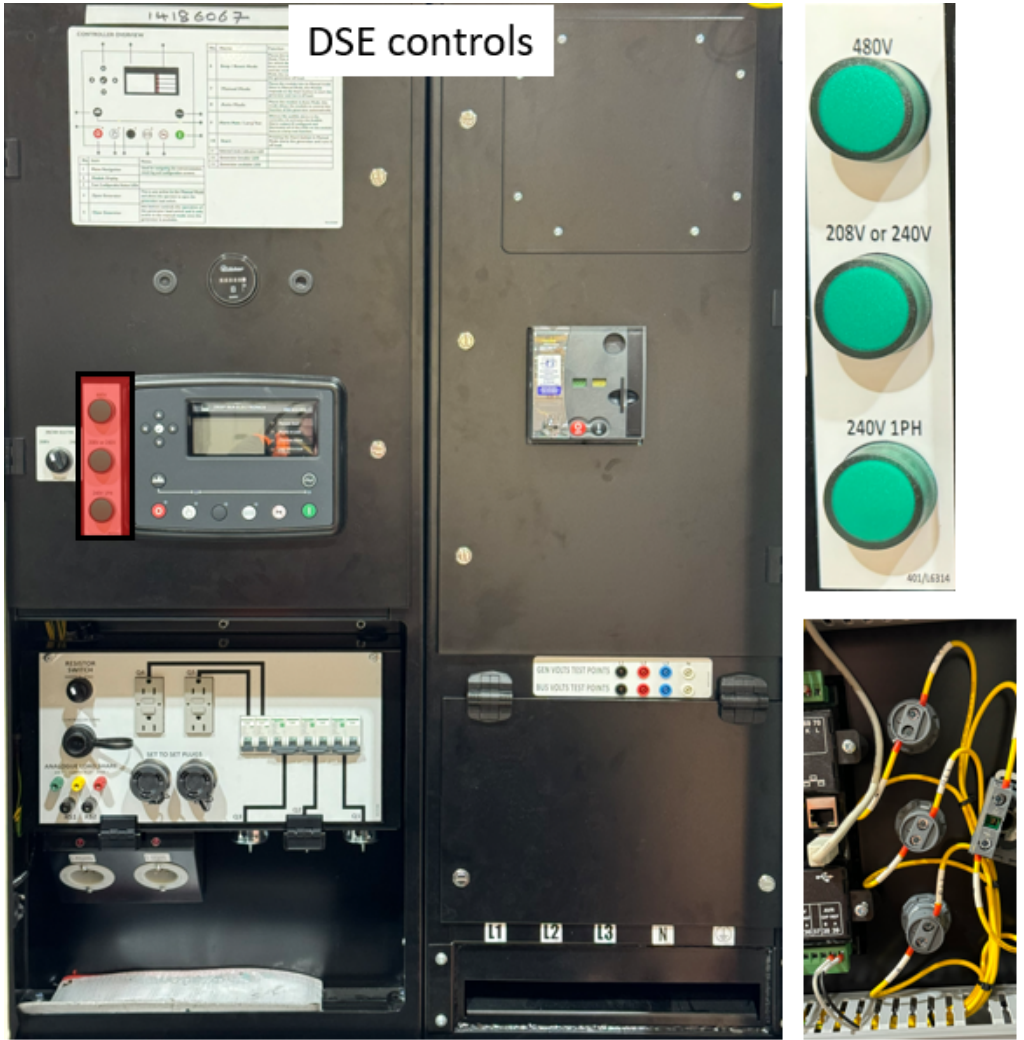
| <b>Location IMG:</b> | |

| | ii. 208V AC Supply<br>iii. 480V AC Supply |
| <b>Location:</b> | Panel Door. |

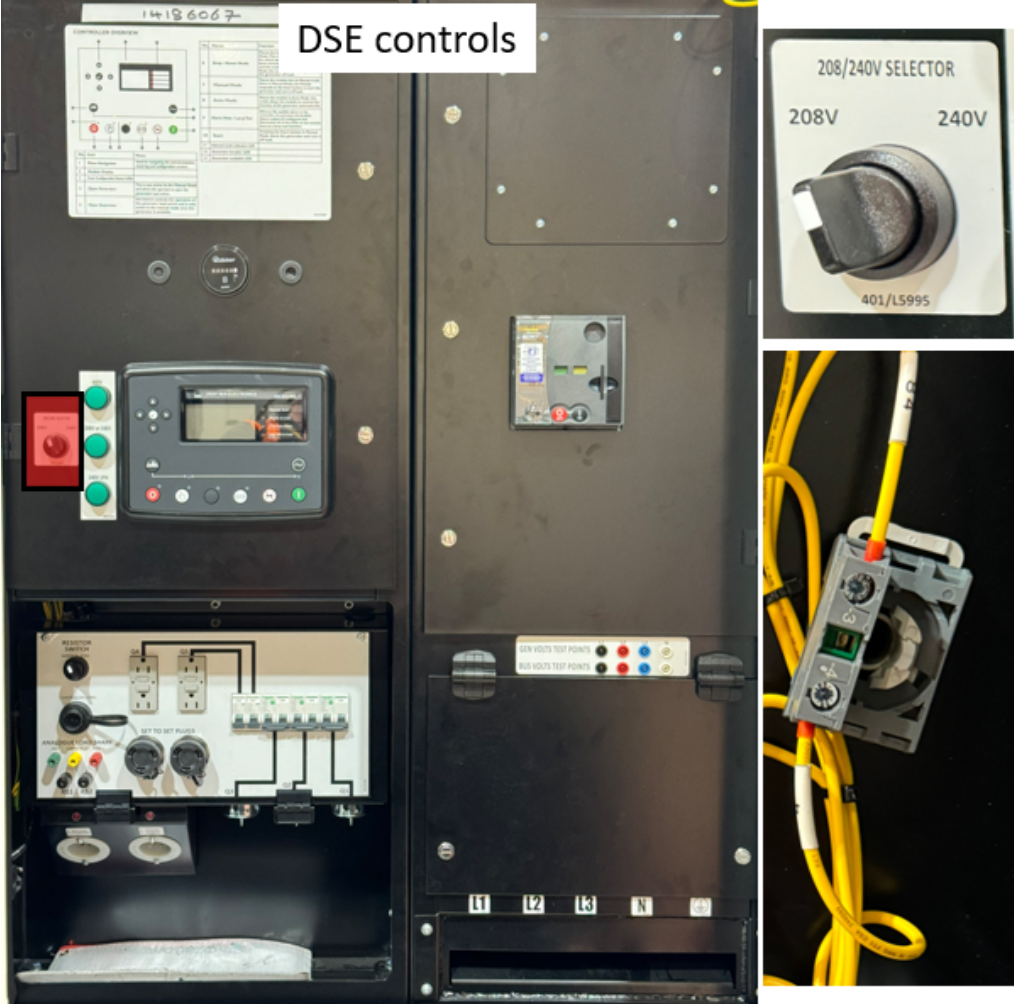
| <b>Function:</b> | On/off switch provided for selecting DSE8610 configuration.<br>Switch On- 240V Selected<br>Switch Off- 208V Selected |
| <b>Location:</b> | Panel Door |

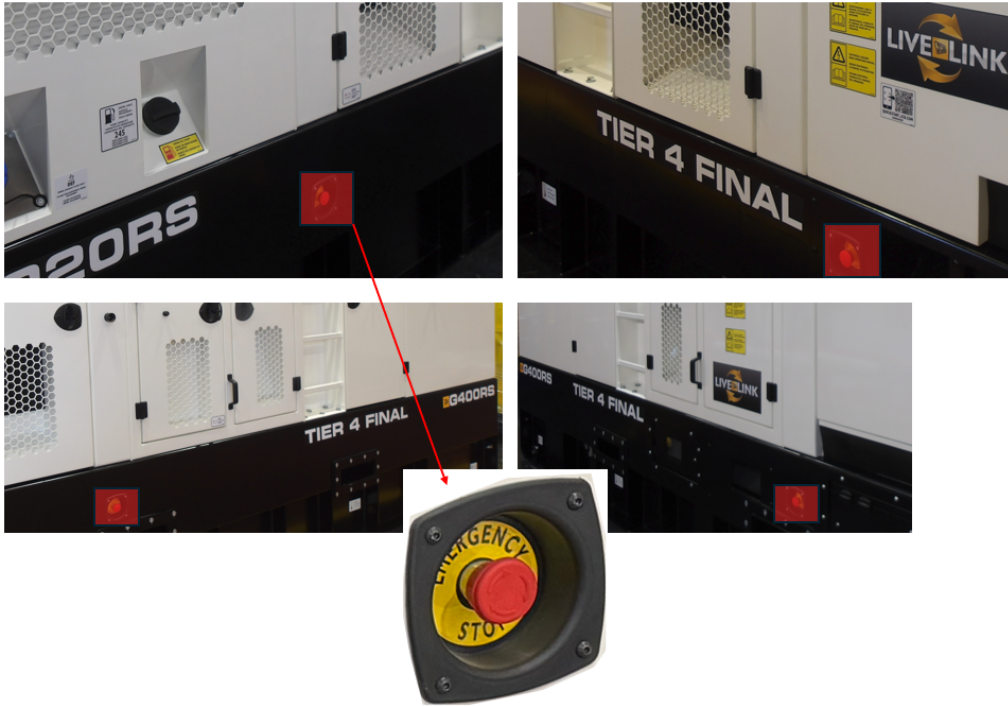
| <b>Function:</b> | Used to shut down the generator in an emergency. |
| <b>Location:</b> | Location:<br>Located externally on both sides of the generator. |

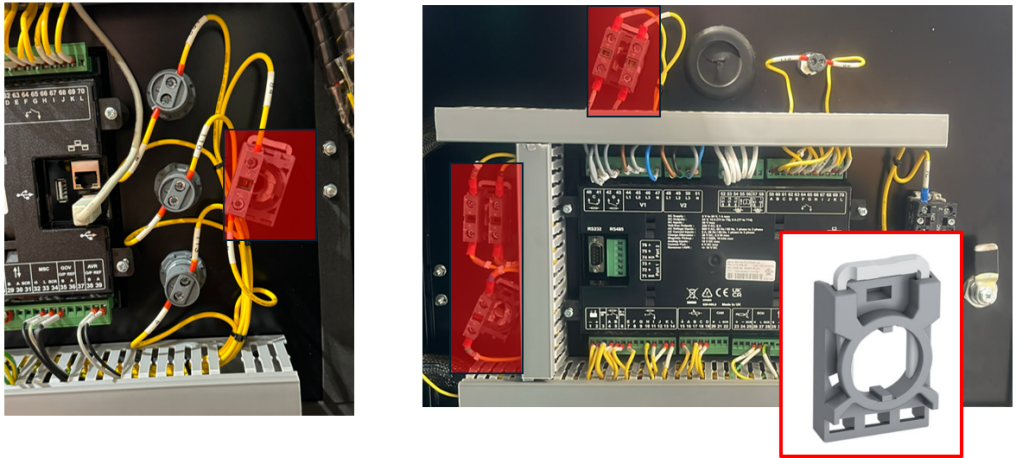
| | <p>2. Panel with Deif Controller:-</p> <p>a. Resistor Switch (Middle set or End Set)</p> |
| <b>Location:</b> | <p>Location:</p> <p>1. Panel with DSE Controller:-</p> <p>a. Control panel DC Door</p> <p>b. Customer interface</p> <p>2. Panel with Deif Controller:-</p> <p>a. Customer interface</p> |

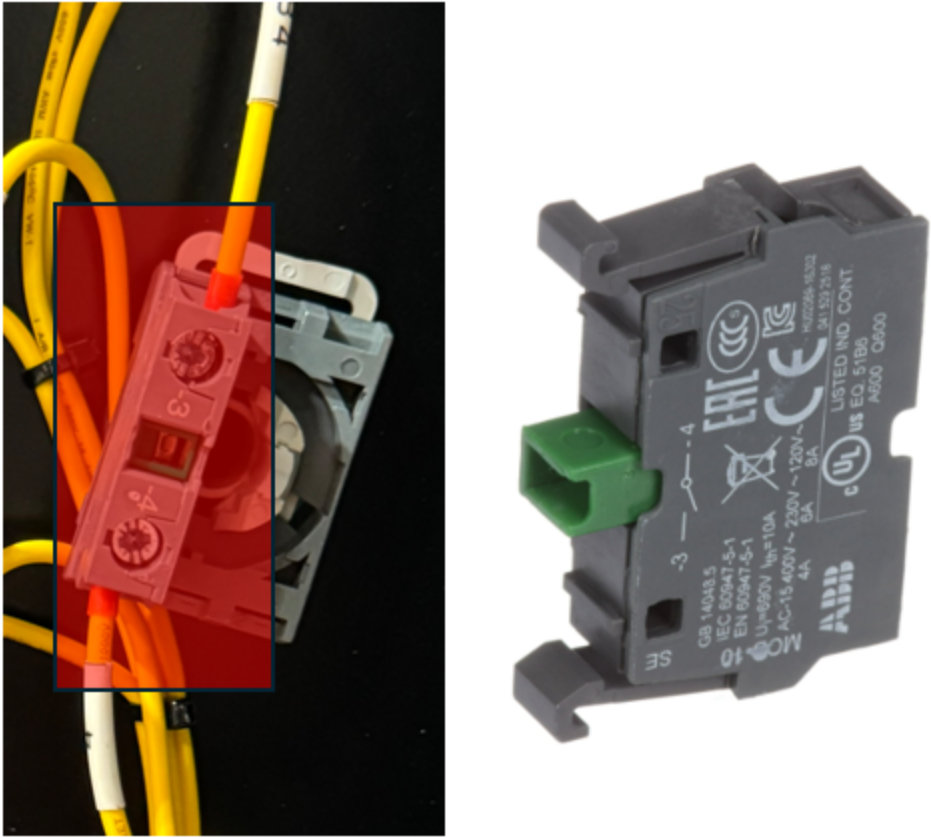
| <b>Function:</b> | <p>Use to connect circuit wires to perform below functions :</p> <ol style="list-style-type: none"> <li>1. Panel with DSE Controller:- <ol style="list-style-type: none"> <li>a. 208/ 240 Voltage Selector</li> <li>b. Resistor Switch (Middle set or End Set)</li> </ol> </li> <li>2. Panel with Deif Controller:- <ol style="list-style-type: none"> <li>a. Resistor Switch (Middle set or End Set)</li> </ol> </li> </ol> |
| <b>Location:</b> | <p>Location:</p> <ol style="list-style-type: none"> <li>1. Panel with DSE Controller:- <ol style="list-style-type: none"> <li>a. Control panel DC Door</li> <li>b. Customer interface</li> </ol> </li> <li>2. Panel with Deif Controller:- <ol style="list-style-type: none"> <li>a. Customer interface</li> </ol> </li> </ol> |
