# **9819-5500-2.3.2: G220RS G400RS G625RS T4F DC Help Files - English (en\_GB)**

## **USER MANUAL**

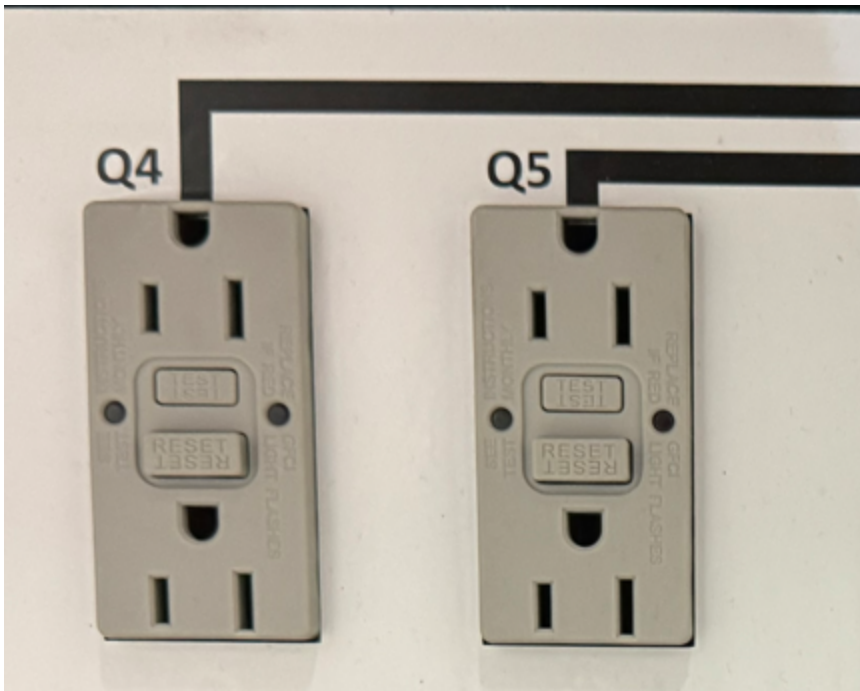
| <b>Function:</b> | In case of Ground Fault, the GFCI is used to isolate AC power to customer appliance to protect human from electric shock. |

| <b>Location:</b> | Location:<br>Customer interface Section. |
| <b>Wires &amp; Connectors IMG:</b> | Q4 - Wire Numbers - 5L2, N, E<br>Q5 - Wire Numbers - 5L1, N, E |

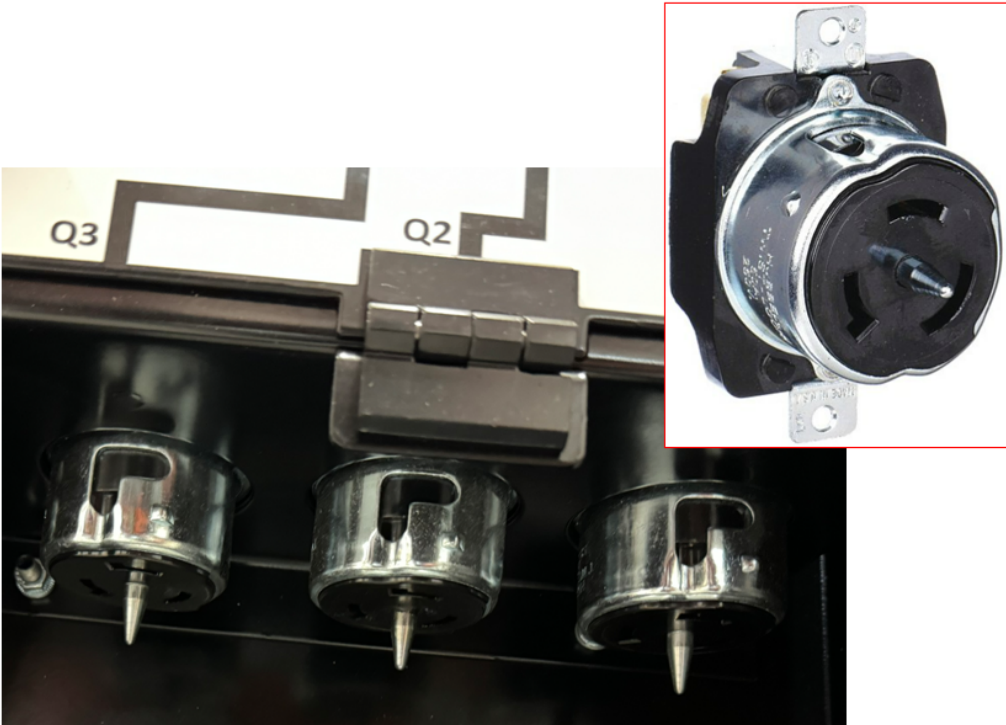
| <b>Function:</b> | <p>Twist lock outlet socket 120VAC</p> <p>A twist lock plug is an locking plug that must be twisted into the Twist Lock Locking Receptacle to make an electrical connection, locking the plug into the receptacle. So that the connection does not become unplugged.</p> |
| <b>Location:</b> | Twist lock outlet socket located inside the control panel. |

| <b>Wires &amp;<br/>Connect<br/>ors IMG:</b> | Q1 - Wire Numbers - 2L1, 2L2, N, E<br>Q2 - Wire Numbers - 3L1, 3L2, N, E<br>Q3 - Wire Numbers - 4L1, 4L2, N, E |

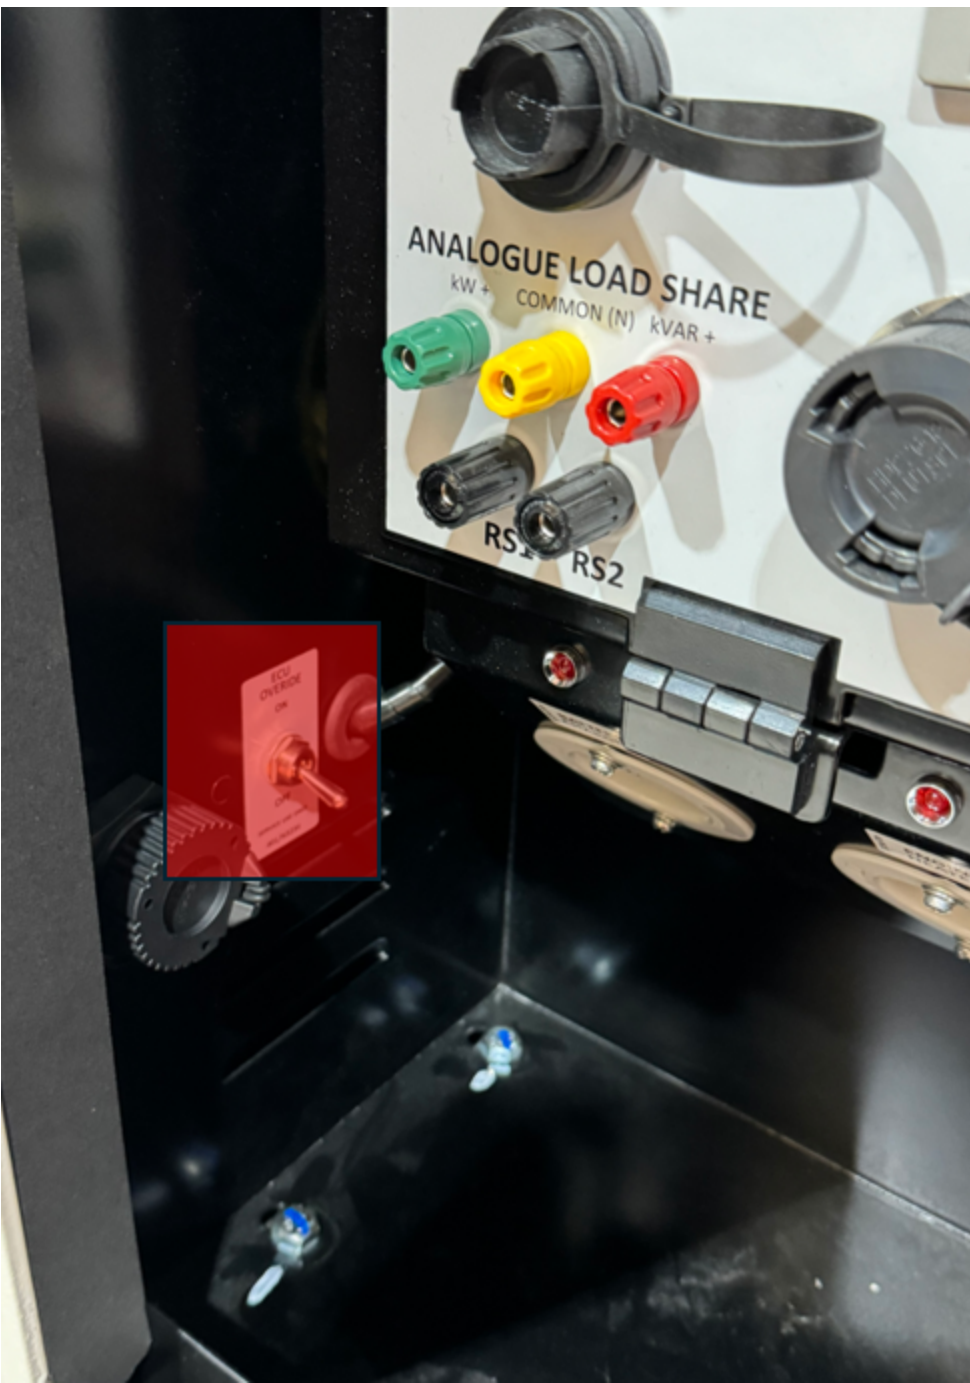
| <b>Function:</b> | ECU Diagnostic switch - Powers up the ECU without having to start the engine. |
| <b>Location:</b> | ECU diagnostic switch located inside the control panel or below socket box (T4F). |

| <b>Wires &amp; Connect</b> | SW1<br>Wire Numbers contact 1 - 15 and 4 |

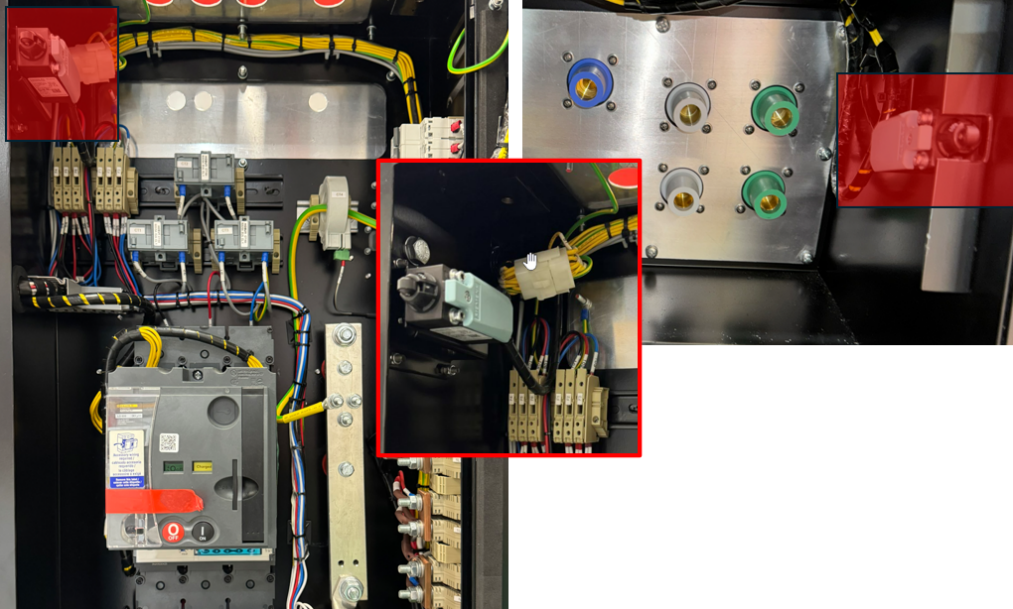
| <b>Function:</b> | <p>Cable access LIMIT SWITCH C/W PLUNGER</p> <p>The Limit Switch is fitted to detect the opening of compartments that contain live conductors. If a door is opened during generator operation, the generator will shut down to prevent harm.</p> |
| <b>Location:</b> | Limit switch located inside the control panel |
| <b>Wires &amp; Connectors IMG:</b> | <p>Cable access door Wire Numbers - 21, 22, 13, 14</p> <p>Breaker Door Wire Numbers - 21, 22, 13, 14</p> |

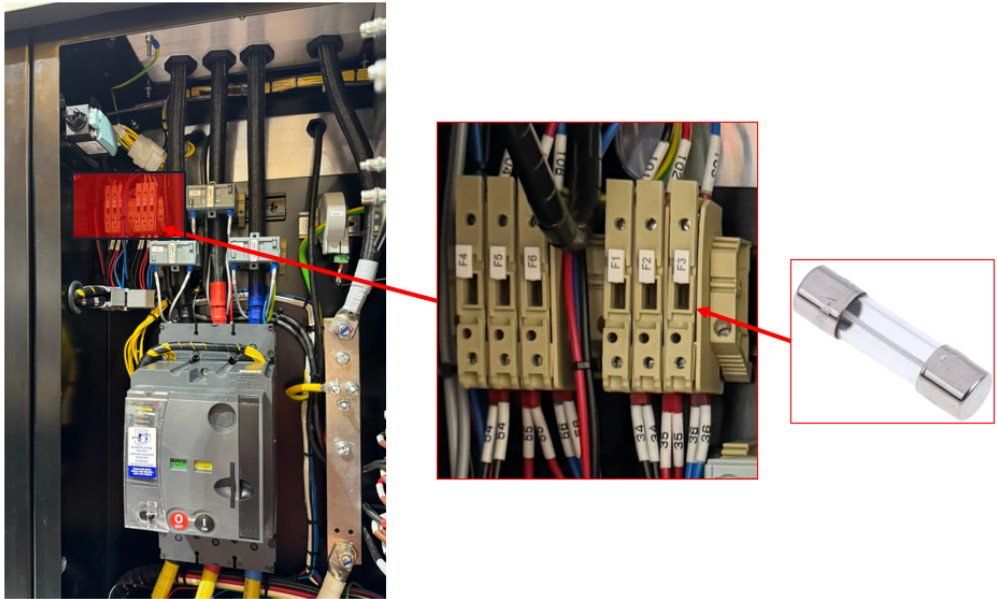
| <b>Function:</b> | <p>Fuse Is used for protection of controller against tranisent voltage /short for the wires tapped for generator votlage sensing and bus voltage Sensing.</p> <p>F1- 2A L1 Generator Voltage Sense<br/>F2- 2A L2 Generator Voltage Sense<br/>F3- 2A L3 Generator Voltage Sense<br/>F4-2A L1 Bus Voltage Sense<br/>F5-2A L2 Bus Voltage Sense<br/>F6-2A L3 Bus Voltage Sense</p> |

| | | | | | | | | | | | | | |
|---|---|---|---|---|---|---|---|---|---|---|---|---|---|
| <b>Location:</b> | Located inside Control panel breaker box top end. | | | | | | | | | | | | |
| <b>Location IMG:</b> |

| | | | | | | | | | | | |
| <b>Signal:</b> | Rated voltage signal from Alternator and Bus. | | | | | | | | | | | | |
| <b>Wires &amp; Connectors IMG:</b> | <p><b><u>Fuse Number - Wire Number</u></b></p>

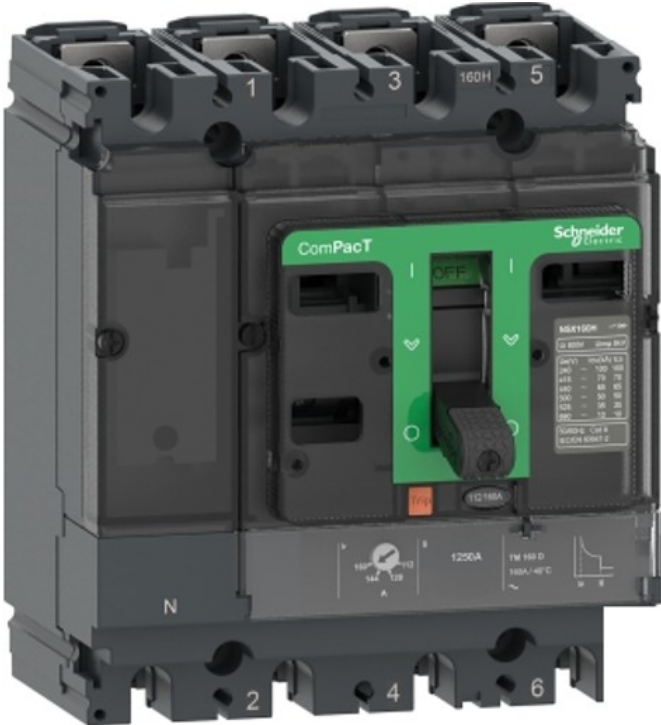
| <b>Function:</b> | MCCB is used inline in between Alternator and load which will interrupt during any power fault like over load and short circuit or any Generator faults |
| <b>Location:</b> | Located inside Control panel breaker box mid Section |

| <b>Wires &amp;<br/>Connect<br/>ors IMG:</b> | <p><b><u>Connected Cables.</u></b></p> <p>L1 - Brown<br/>L2 - Black<br/>L3 - Grey<br/>N - Blue<br/>Earth - Green/Yellow</p> <p>Phase power cables will vary depending on generator node size.</p> |

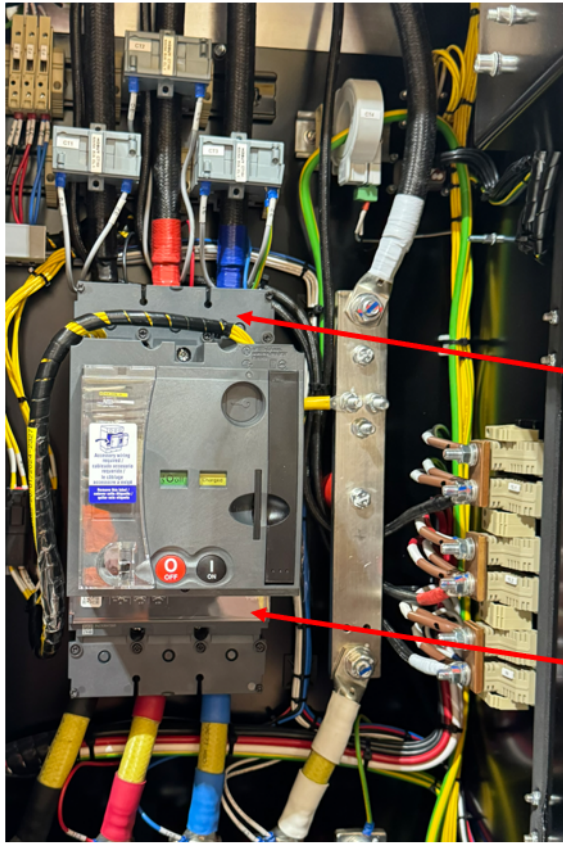
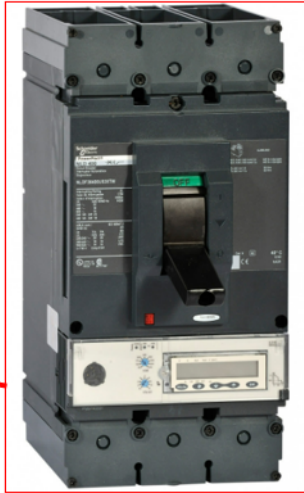
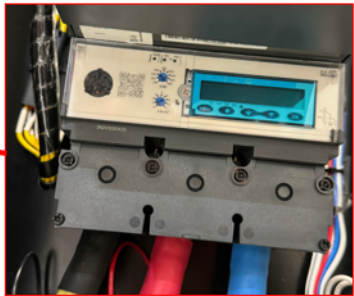
| <b>Function:</b> | The MCCB is used inline in between Alternator and load which will interrupt during any power fault like over load and short circuit or any Generator faults |
| <b>Location:</b> | Located inside Control panel breaker box mid Section |

| <b>Wires &amp; Connectors IMG:</b> | <b><u>Cable Numbers</u></b><br>L1 - Black<br>L2 - Red<br>L3 - Blue<br><br>Phase power cable 120 Sq mm |

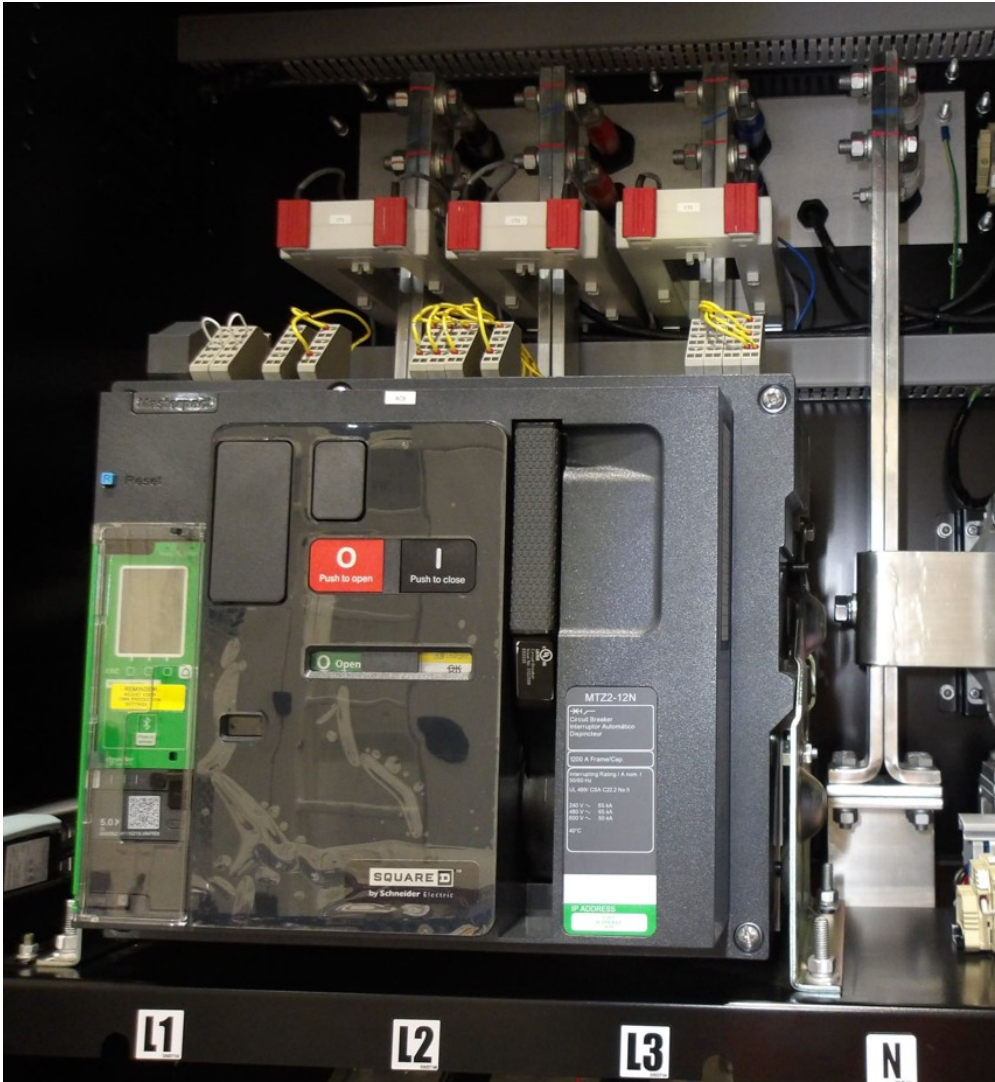
| <b>Function:</b> | ACB is used inline in between Alternator and load which interrupts during any power fault like over load and shortcircuit or any Generator faults |
| <b>Location:</b> | Located inside Control panel breaker box mid Section |

| <b>Wires &amp; Connectors IMG:</b> | <p><b><u>Cable Numbers</u></b></p> <p>L1 - Black<br/>L2 - Red<br/>L3 - Blue</p> <p>Phase power cable 120 Sq mm</p> |

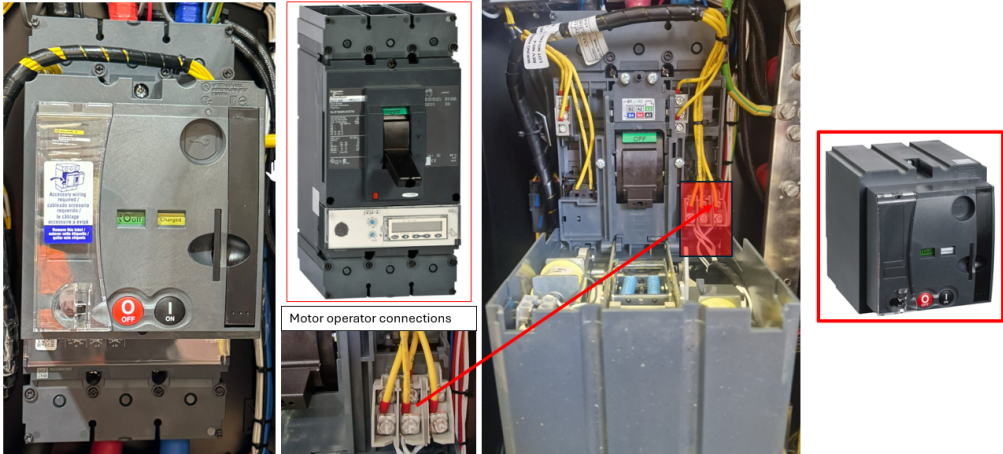
| <b>Function:</b> | Motor operator (Motor Mech) is fitted to the MCCB to fully automate the opening and closing of the breaker |
| <b>Location:</b> | Located inside Control panel breaker and mounted to the main MCCB. |

| <b>Wires &amp;<br/>Connect<br/>ors IMG:</b> | Wire Numbers - 92, 4, 93, 94. |

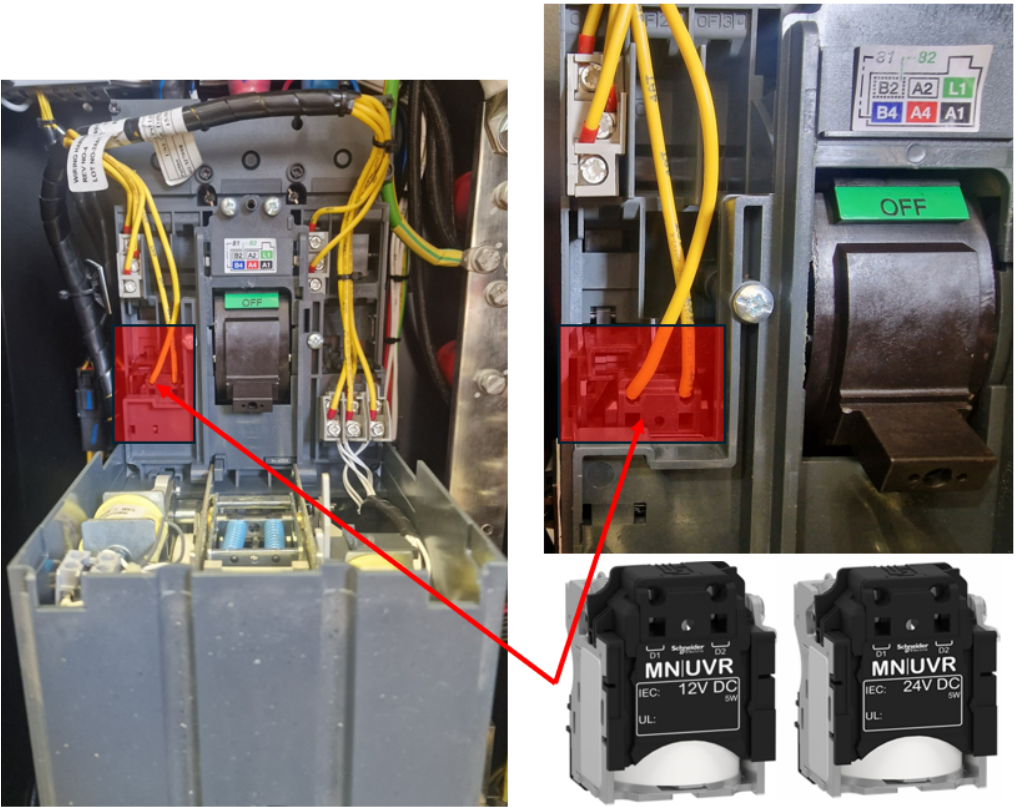
| <b>Function:</b> | Under voltage coil is used as a safety feature to open the MCCB on fault. |
| <b>Location:</b> | Located inside Control panel and inside main MCCB. Motor operator mounted over coil. |

| <b>Wires &amp; Connectors IMG:</b> | Wire Numbers - 47 and 4 |

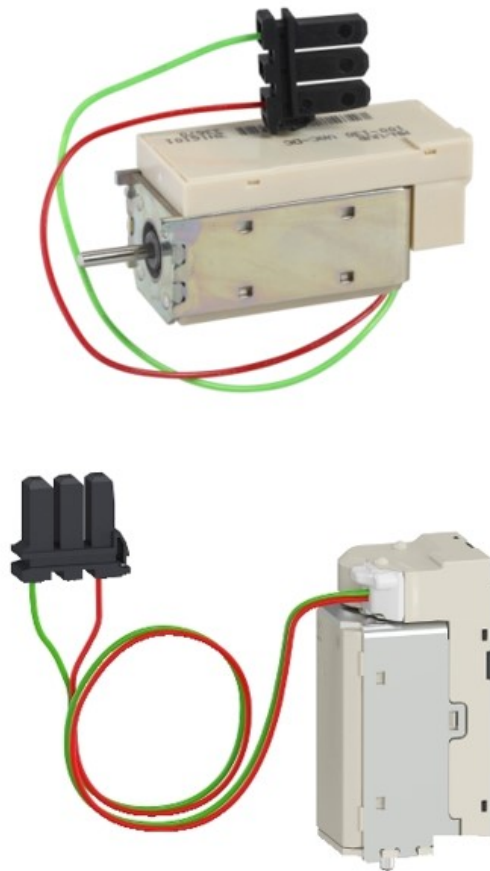
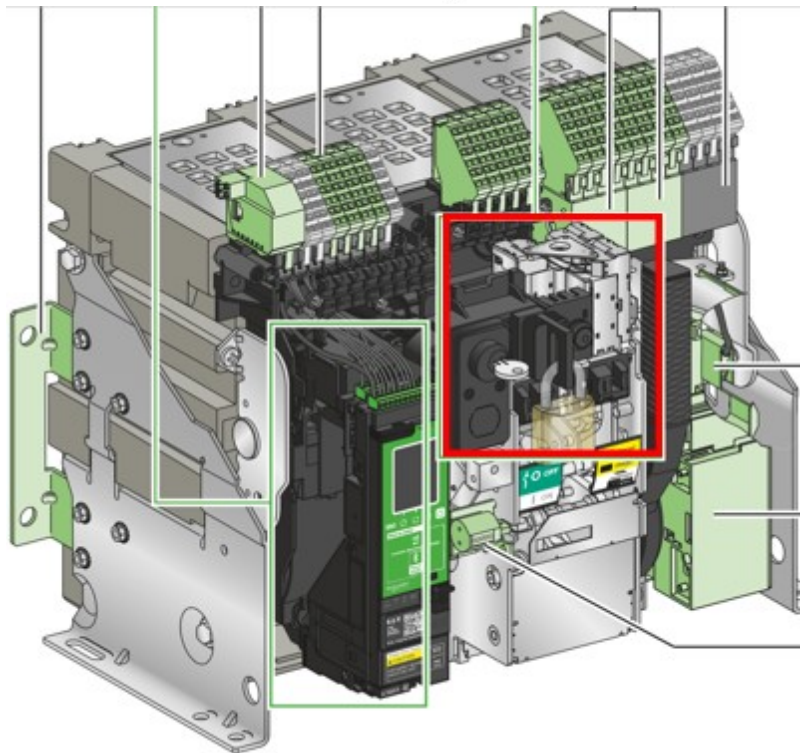
Location  
IMG:

| <b>Location:</b> | Located inside main ACB. |

| <b>Wires &amp; Connectors IMG:</b> | Wire Numbers - 94 and 4 MX<br>Wire Numbers - 47 and 4 MN |

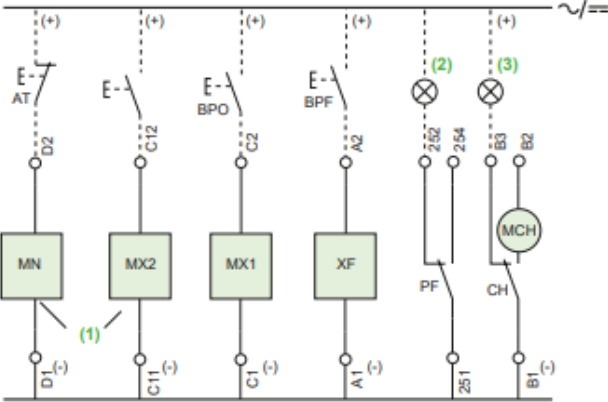
| <b>Testing:</b> | <p>Common issue to look at with UV/shunt coils is that the breaker may trip instantly on closing, this will happen on motor operated breakers and manual breakers.</p> <p>Test for DC voltage at the under voltage coil, the circuit should be functional when generator is not running, but with battery isolator on.</p> <p>The circuit for MN coil is also part of the emergency stop circuit and the door switches. which should be a normally closed circuit.</p> <p>Supply is from CD3, through fault contact on ELR that supplies the REL relay but also goes through the contact side of the RST relay, then through the door switches and then e.stop contact 2's.</p> <p>DC positive circuit to be measured.</p> |

| | <p>en (1) Possibility to add a second MX (MX2) or MN voltage release<br/>(2) Ready to close<br/>(3) Charged</p> |

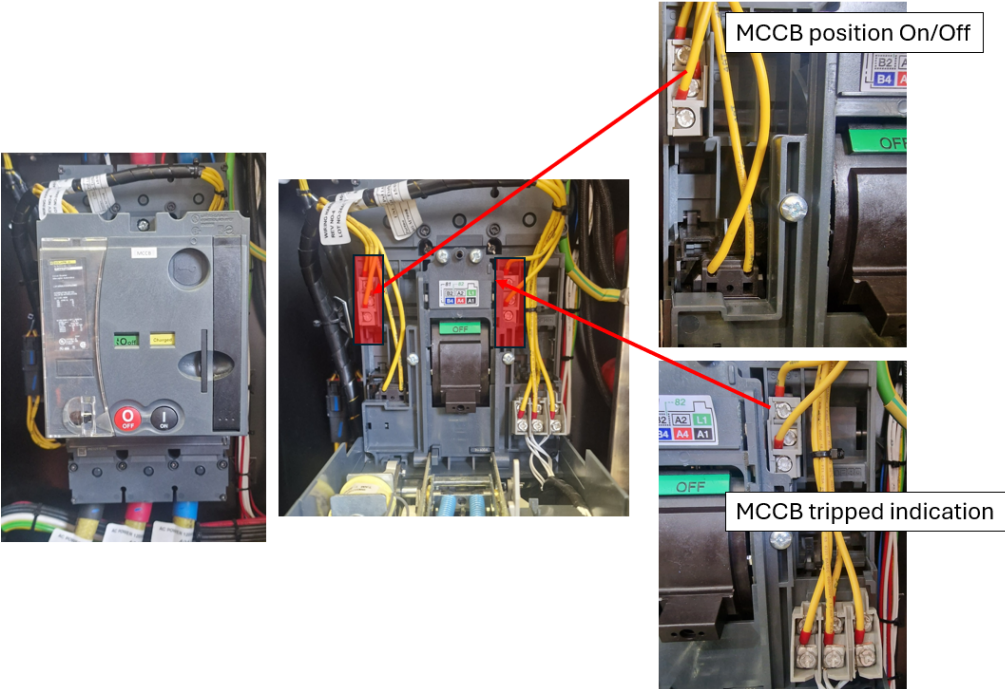
| <b>Function:</b> | Contacts send feedback to the controller on the status of the breaker. |
| <b>Location:</b> | Located inside Control panel and inside main MCCB. Motor operator mounted over contacts. |

| <b>Location IMG:</b> | <p>MCCB position On/Off</p> <p>MCCB tripped indication</p> |
| <b>Wires &amp; Connectors IMG:</b> | Wire Numbers - 90, 19, 18 and 4. |

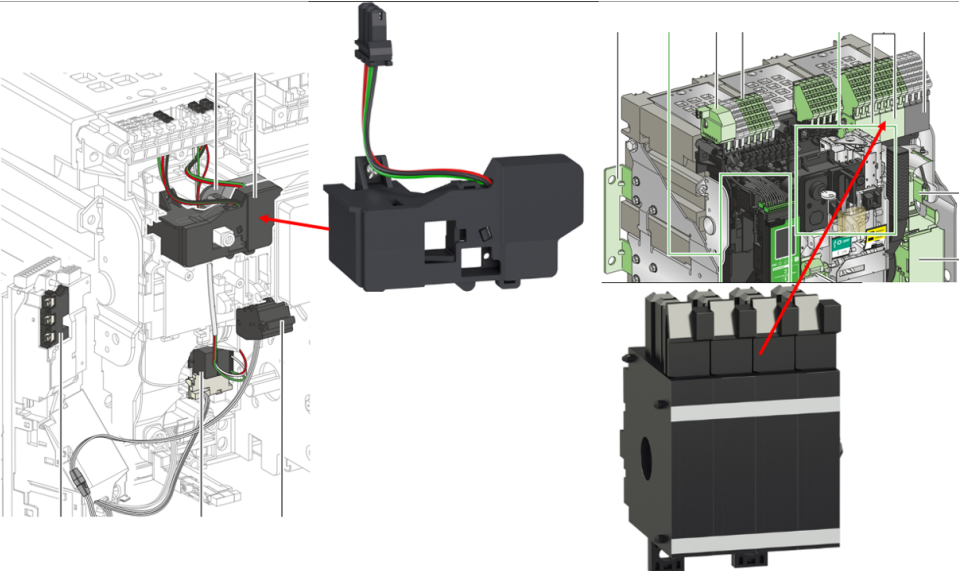
| <b>Function:</b> | Contacts send feedback to the controller on the status of the breaker. |
| <b>Location:</b> | Located inside Control panel and inside main ACB. Motor operator mounted over contacts. |
| <b>Wires &amp; Connectors IMG:</b> | Wire Numbers - 90, 19, 18 and 4. |

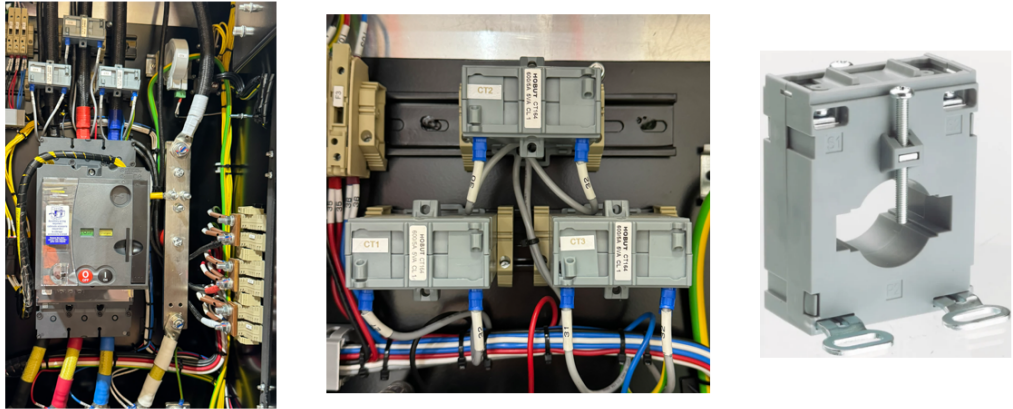
| <b>Function:</b> | The CT (Current Transformer) transforms the primary current being measured into a 5A secondary current for safe controller measurement of amps/power. |

| <b>Location:</b> | Mounted inside the AC section of the controls enclosure above the MCCB. |
| <b>Wires &amp; Connectors IMG:</b> | Wire Numbers - 29,30,31 and 32 |

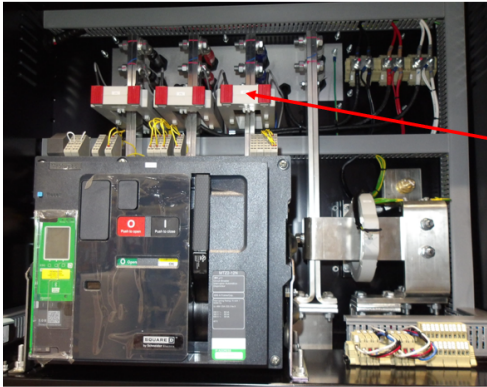
| <b>Function:</b> | The CT (Current Transformer) transforms the primary current being measured into a 5A secondary current for safe controller measurement of amps/power. |
| <b>Location:</b> | Mounted inside the AC section of the controls enclosure above the ACB. |
| <b>Wires &amp; Connectors IMG:</b> | Wire Numbers - 29,30,31 and 32 |

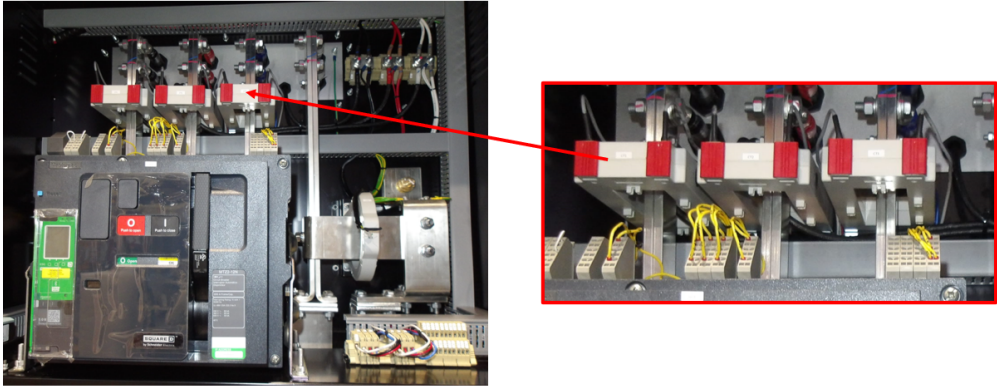
| <b>Location:</b> | Mounted inside the AC section of the controls enclosure above the ACB. |
| <b>Wires &amp; Connectors IMG:</b> | Wire Numbers - 29,30,31 and 32 |

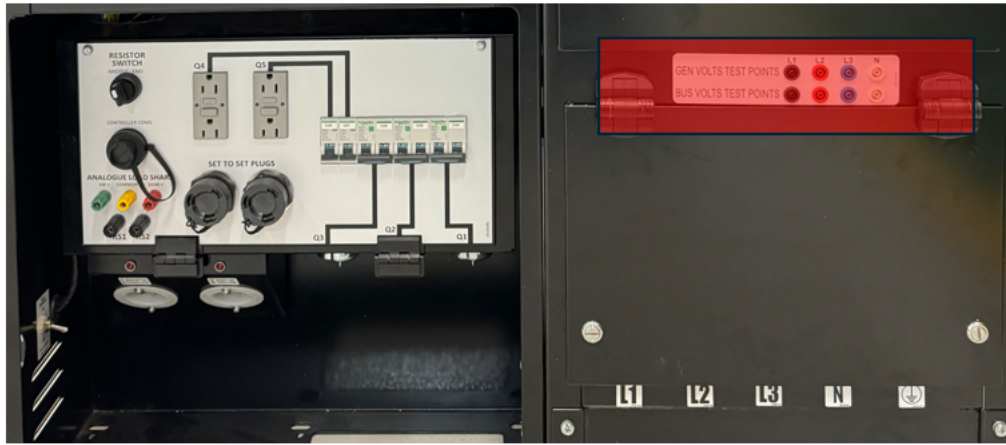
| <b>Function:</b> | Test plug are used to test the voltages of Genset voltage and Bus bar voltage without direct contact with bus bars |
| <b>Location:</b> | Located on controls enclosure AC section. Black, Red, Blue and White. |
| <b>Wires &amp; Connectors IMG:</b> | <b>Generator Voltage Sensing</b><br><u>Fuse Number - Wire Number</u> |

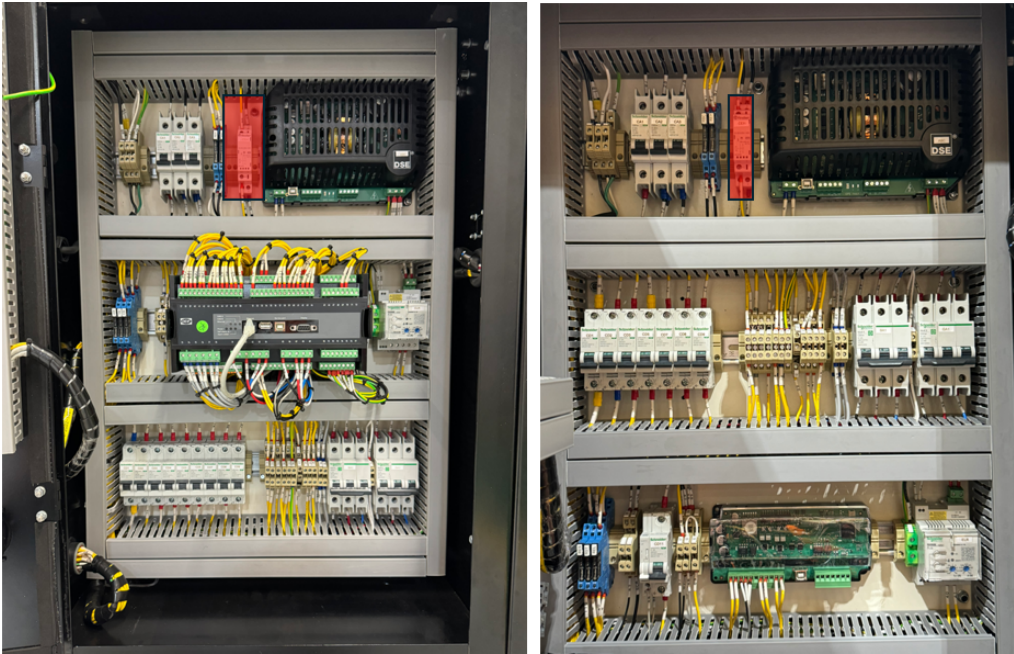
| <b>Function:</b> | CEH - Contactor Engine Heater |
| <b>Location:</b> | Relay is located inside the control panel |
| <b>Wires &amp; Connectors IMG:</b> | <p>Wire numbers</p> <p>4 and 66 - Relay Coil</p> <p>61 and 62 - NC Contact</p> <p>67 and 68 - NC Contact</p> |

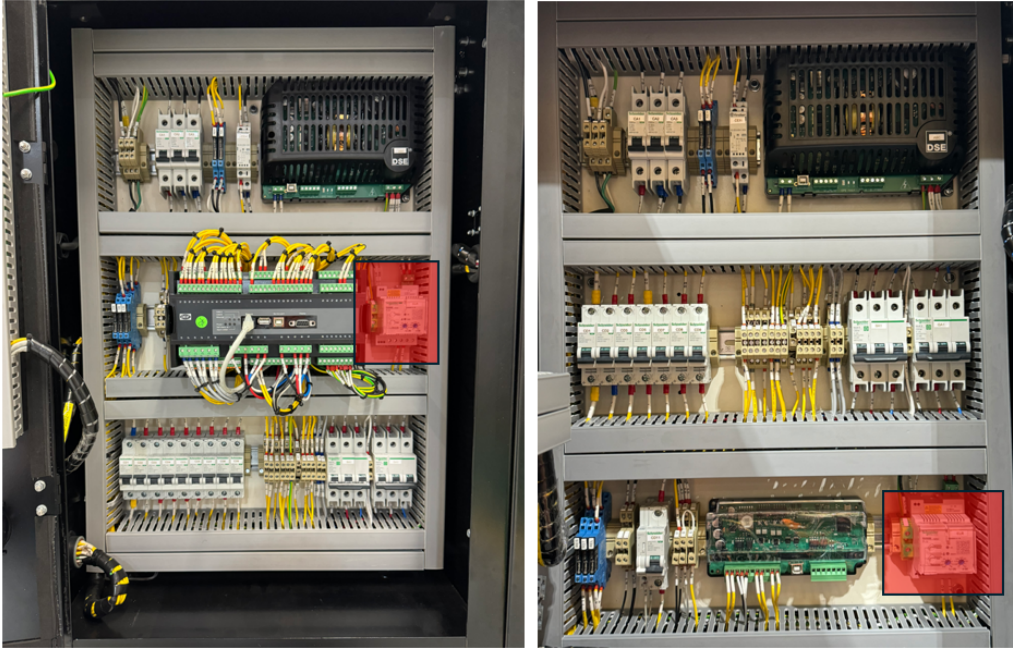
| <b>Function:</b> | To measure the earth leakage current & operate the shunt in case of fault |
| <b>Location:</b> | Relay is located inside the control panel |
| <b>Wires &amp; Connectors IMG:</b> | <p>Wire Numbers</p> <p>P1 and P2 - Sensing</p> <p>37 and 4 - Relay coil</p> <p>40 and 41 - Output</p> |

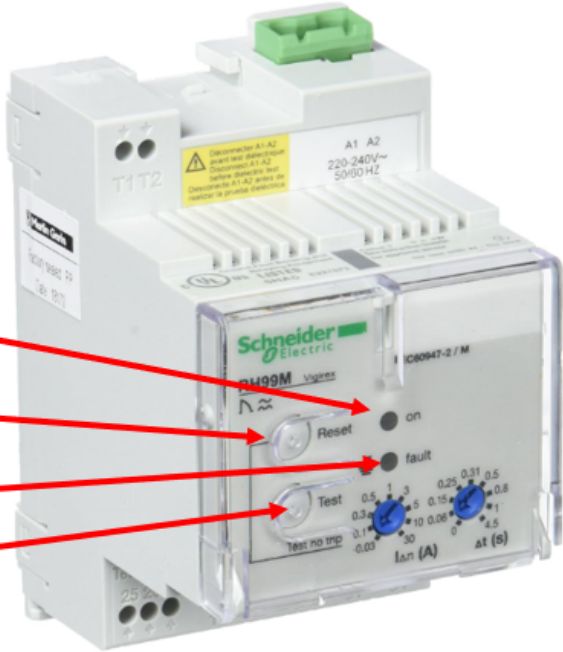
| <b>Testing:</b> | <div><div><div>1. Check for power on the ELR (Earth Leakage Relay).</div><div>2. Test the ELR by closing the MCCB and pressing the test button on the ELR.</div><div>3. Test the ELR circuit using a calibrated RCD tester. Set up for 30mA and X1 and trip within 300mS.</div><div>4. Toroid can also cause nuisance tripping if not connected correctly or loose connections on wiring.</div><div>5. Replace if not functioning.</div></div><div><div><div>Power LED</div><div>Reset Button</div><div>Fault LED</div><div>Test Button</div></div><div></div></div></div> |

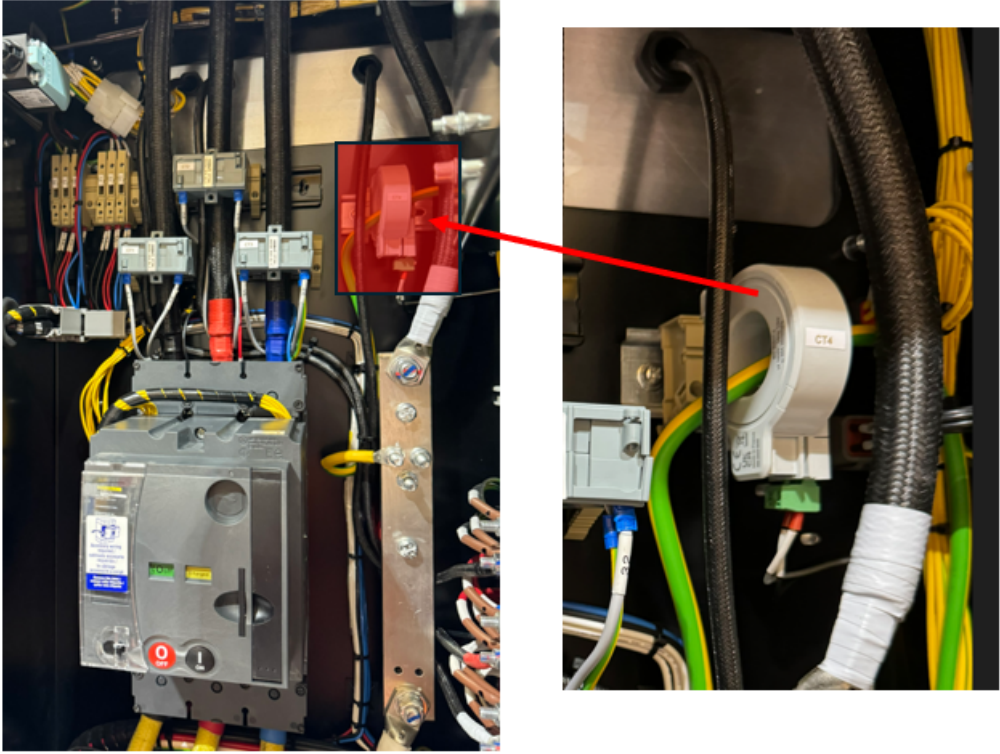
| Function: | To measure the earth leakage current |
| Location: | CT Toroid is located inside the Breaker box |
| Wires & Connect ors IMG: | Wire Numbers - P1 and P2<br>Toroid Terminals - S1 and S2 |

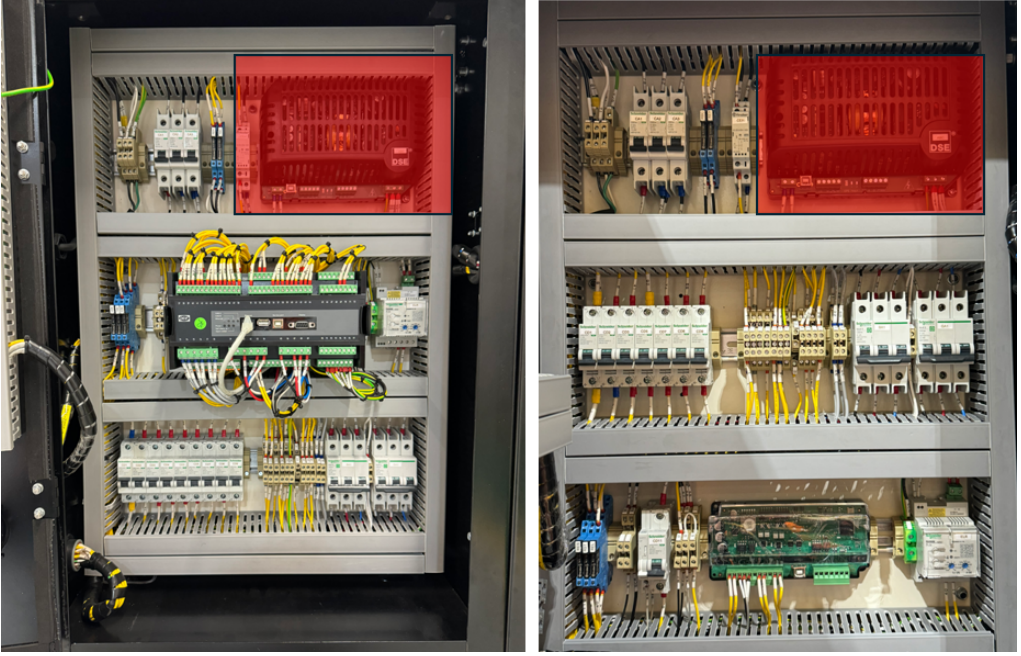
| <b>Function:</b> | DC charging supply for battery. |
| <b>Location:</b> | Battery charger is located inside the control panel. |

| <b>Wires &amp;<br/>Connect<br/>ors IMG:</b> | Wire Numbers<br><br>73, 69 and YG - AC Supply<br>1 and 4 - DC supply |

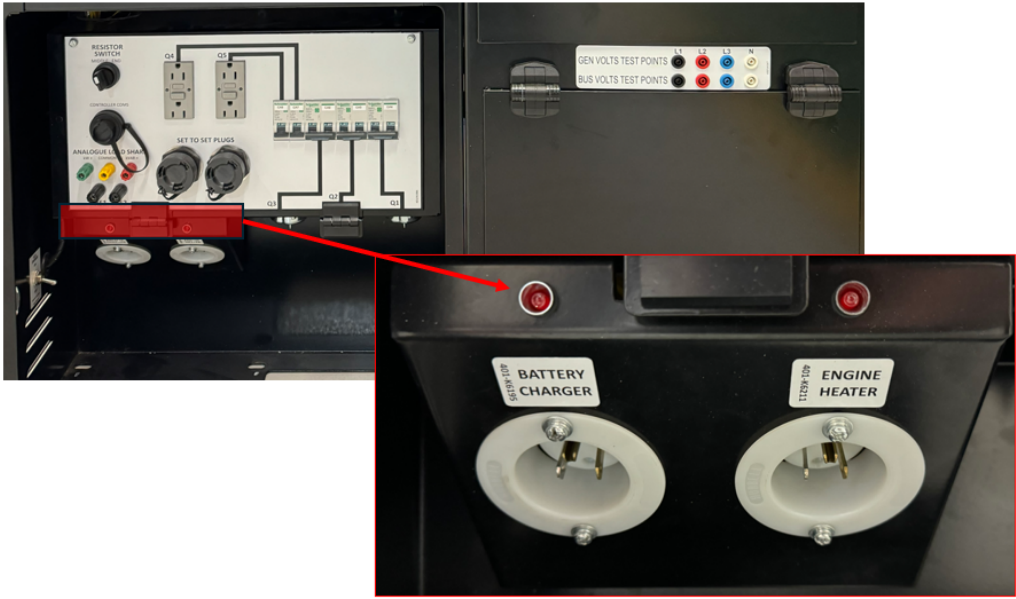
| <b>Function:</b> | 24VDC LED for indication of Inlet plug is live (power on) |
| <b>Location:</b> | Located above Aux inlet plug |
| <b>Wires &amp; Connectors IMG:</b> | <p>Wire Numbers</p> <p>4 and 75</p> <p>4 and 76</p> |

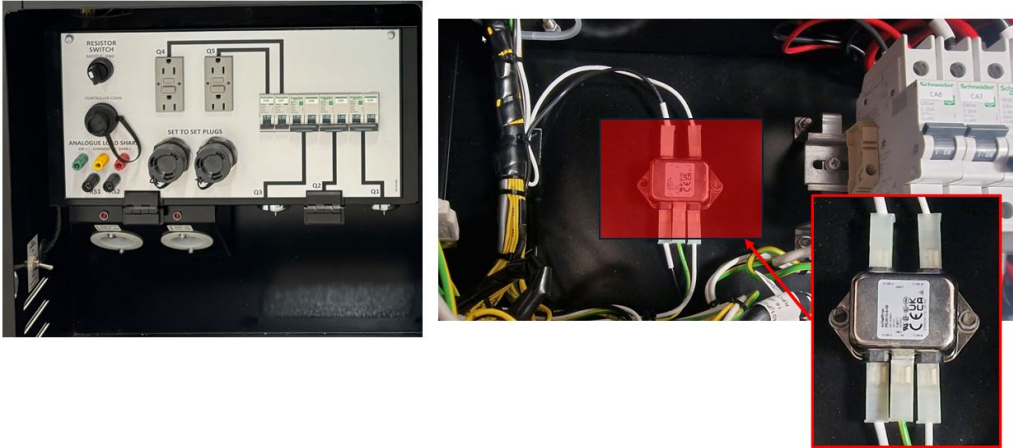
| <b>Function:</b> | To Reduce electro-magnetic disturbances (AC side) | |
| <b>Location:</b> | Located behind Socket box front plate, inside control panel. | |

| <b>Wires &amp; Connectors IMG:</b> | Wire Numbers<br>64, 65, 70 and 69 |

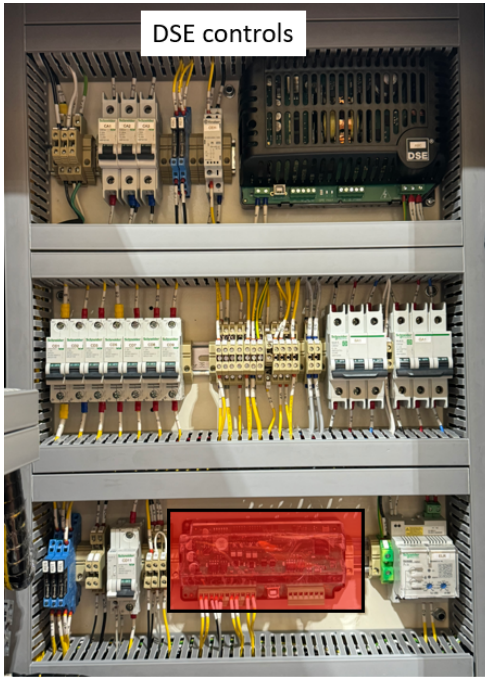
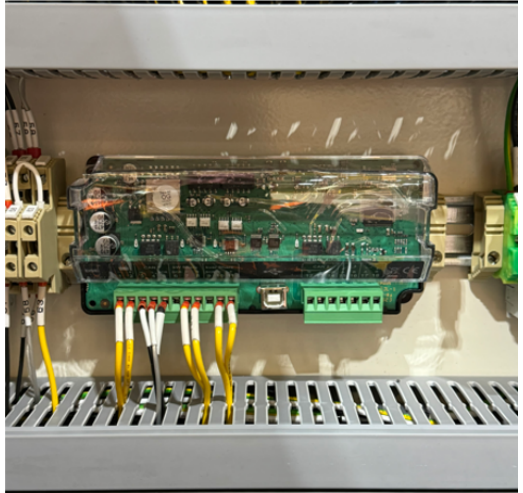
| <b>Function:</b> | The DSE123 is an intelligent device that allows DSE 8610 load share modules to communicate with non-DSE control modules that are communicating over universal analogue load share lines. This means When we Synchronize Generator with DSE8610 with other generator controller having Analog based load share, then we need DSE123 to established communication between these controller for KW & KVAR sharing. | |
| <b>Location:</b> | Inside Panel. | |
| <b>Wires &amp; Connectors IMG:</b> | Wire Numbers - 4 and 7<br>Wire Numbers - 57 and 58<br>Wire Numbers -121,122 and 123 | |

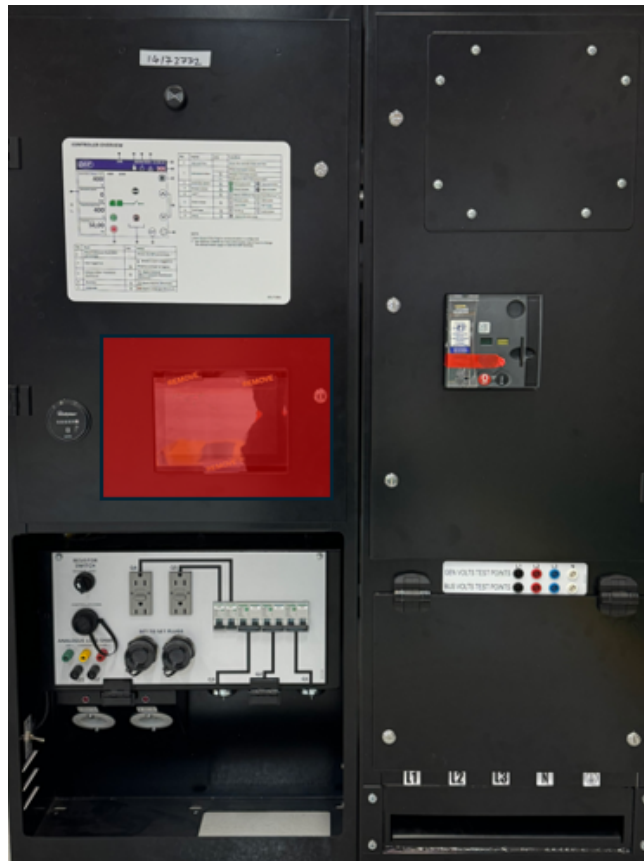
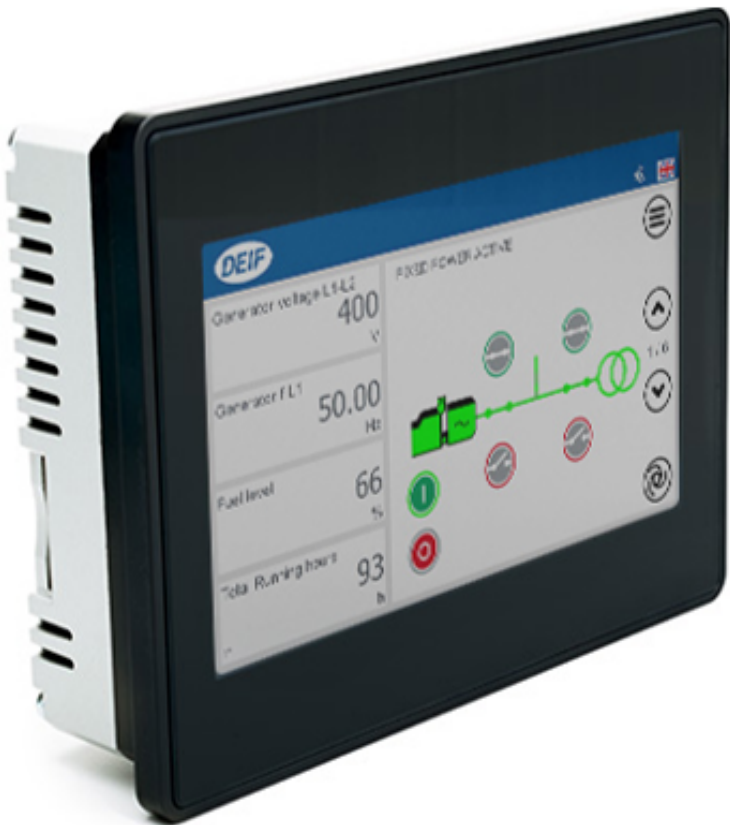
Location  
IMG:

| <b>Location:</b> | Control Panel |

| <b>Wires &amp; Connectors IMG:</b> | Wire Numbers<br>C1, C3, 4 and 100 |

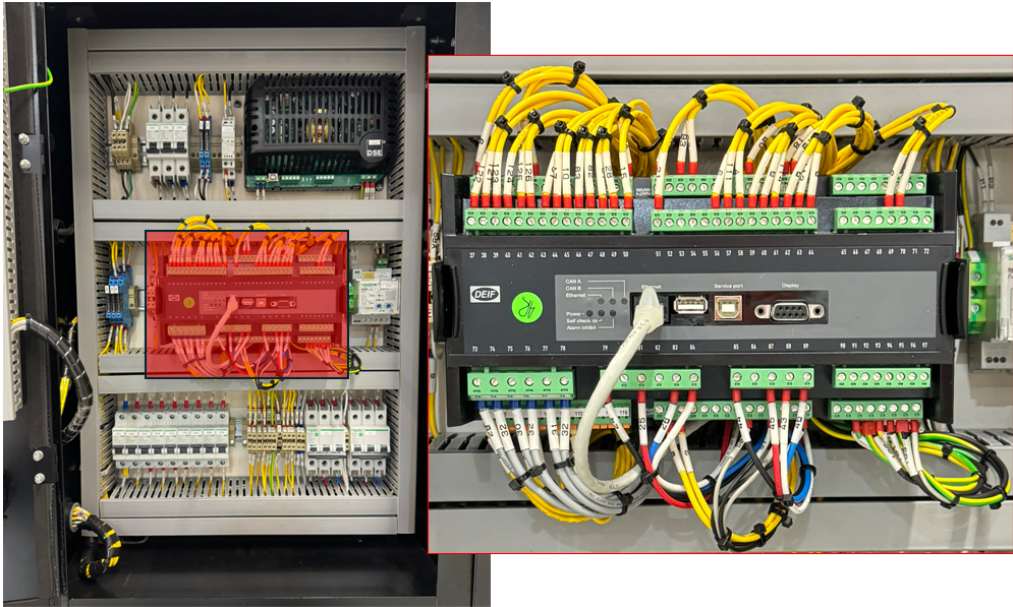
| <b>Function:</b> | Main controller for generator |
| <b>Location:</b> | Behind control TDU display door. |

| <b>Wires &amp; Connectors IMG:</b> | Reserved for options, see <i>Data sheet</i> . | | 36 | <div>Slot #2</div> <div>Slot #1</div> | 97 | Reserved for options, see <i>Data sheet</i> . | |

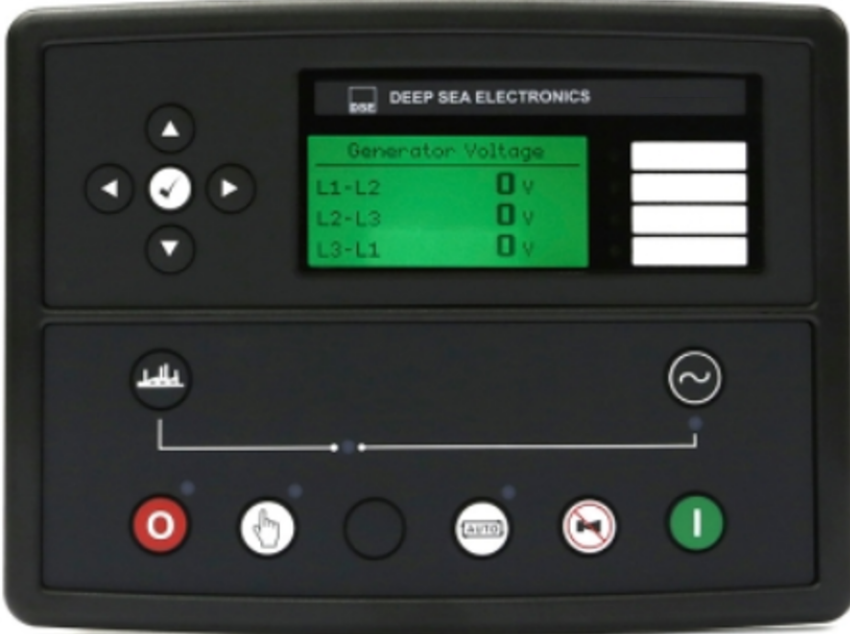
| <b>Function:</b> | <p>Main generator control unit</p> <p>The image shows a black rectangular generator controller unit. At the top, it has a green LCD screen displaying 'Generator Voltage' and three rows of data: 'L1-L2 0 V', 'L2-L3 0 V', and 'L3-L1 0 V'. To the left of the screen are four directional buttons (up, down, left, right) and a central checkmark button. Below the screen is a horizontal slider control. At the bottom, there are six circular buttons: a red 'O' button, a white button with a hand icon, a black button, a white 'AUTO' button, a red button with a crossed-out hand icon, and a green 'I' button. Above the buttons are two icons: a factory building and a sine wave symbol.</p> |

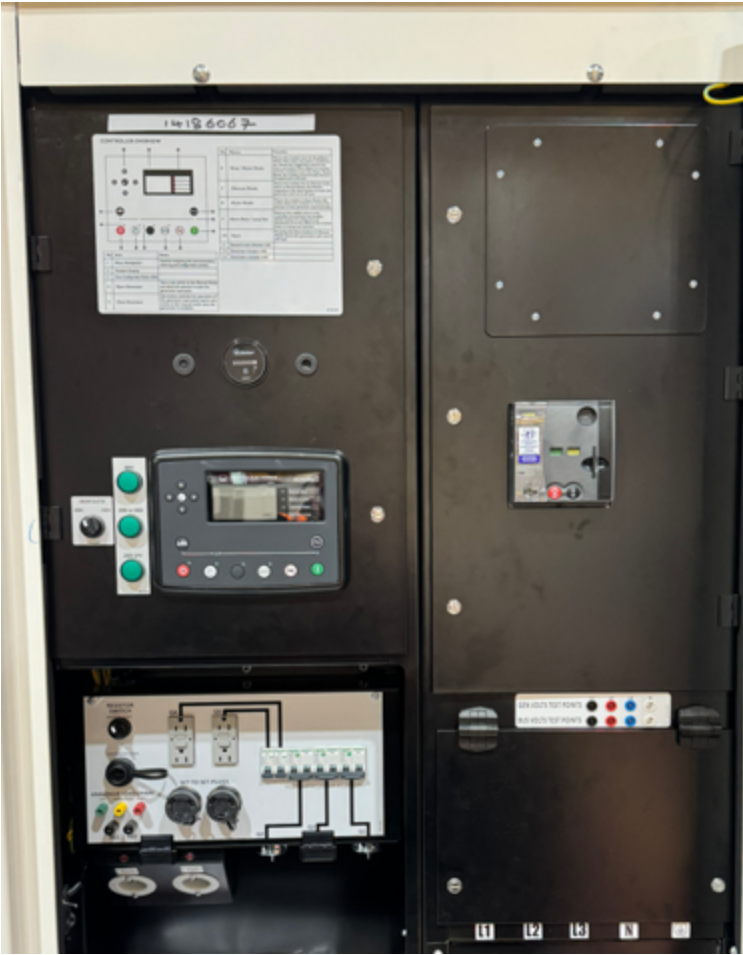
| <b>Location:</b> | Located on Control panel door. |

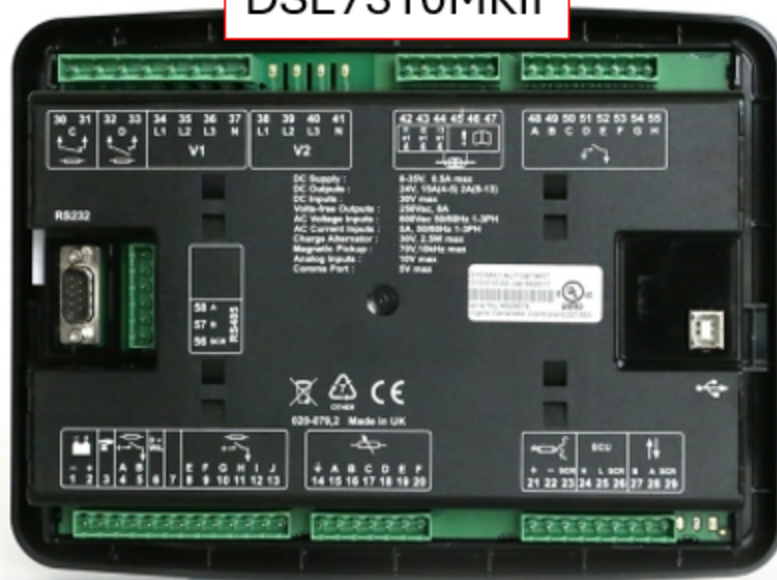
### DSE7310MKII

**Wires &  
Connect  
ors IMG:**
