# **9819-5500-2.3.2: G220RS G400RS G625RS T4F DC Help Files - English (en\_GB)**

## **USER MANUAL**

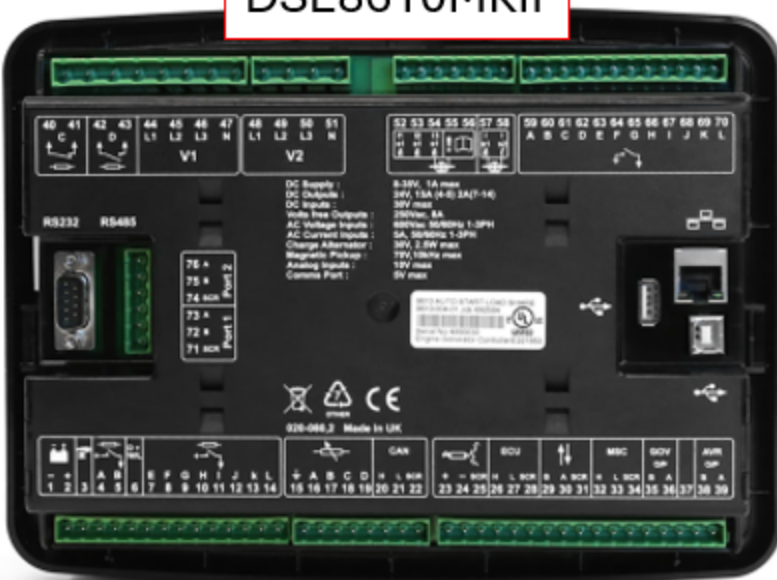
### DSE8610MKII

**Wires &  
Connect  
ors IMG:**

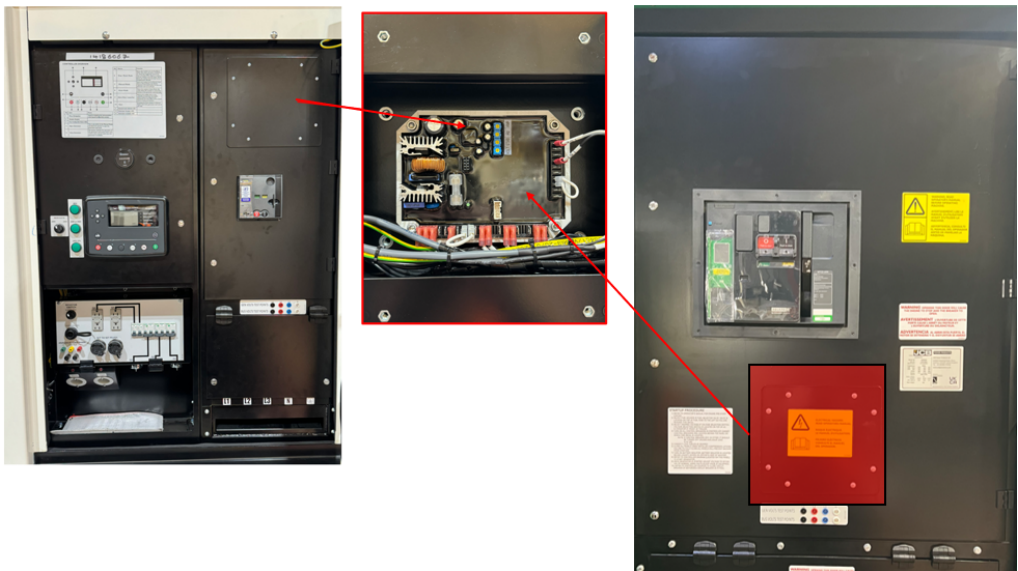
| Location: | Located inside Control panel enclosure, behind a surface mounted panel. | |

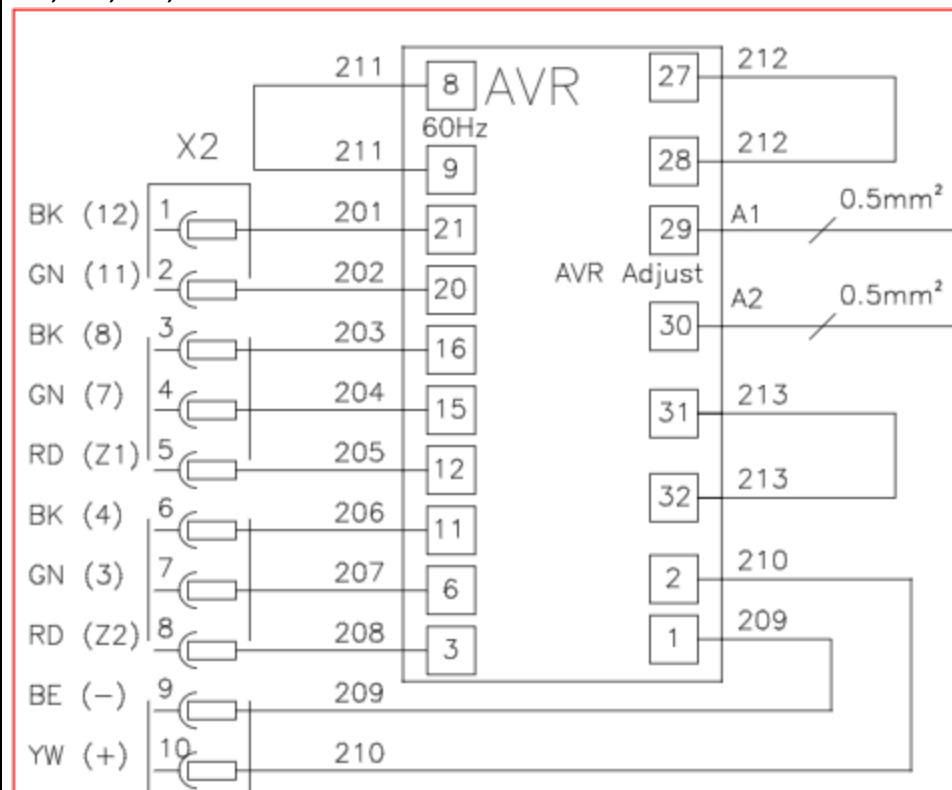
For over voltage shutdowns/eratic voltages.

Check all connections for the voltage input sensing on terminals 6, 11, 15, 16, 20 and 21.

- With connections removed from terminals 1 and 2 of the DER, check resistance of the excitor field which should measure 10-15ohms, if there is no reading, the excitor circuit is open.
- Check Aux circuit wiring on terminal 3 (Z2) and 12 (Z1) (both red), check connections and damage. A good AUX circuit should be 1ohm on testing.
- If excitor and auxiliary circuits have tested good and are visually ok, reconnect the auxiliary Z1 and Z2. The blue and yellow wires from terminal 1 and 2 will need to be prepared ready for seperatly exciting the alternator with a 9V battery.
- Start the generator, make sure you have "Gen Volts" on display and then place the blue on negative and the yellow on positive. If the volts increase to near nominal, the regulator has failed and will need replacing.

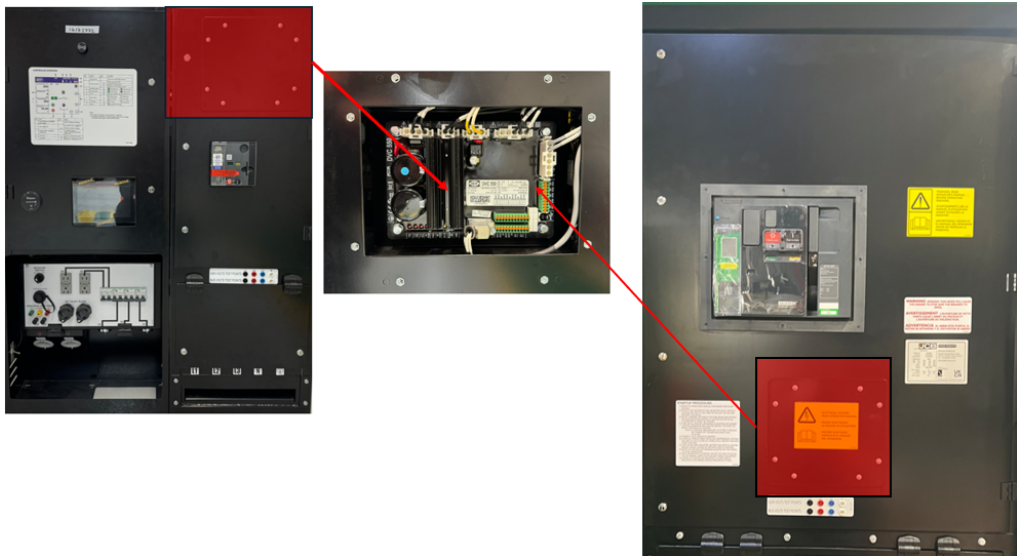
| <b>Location:</b> | Breaker Panel |

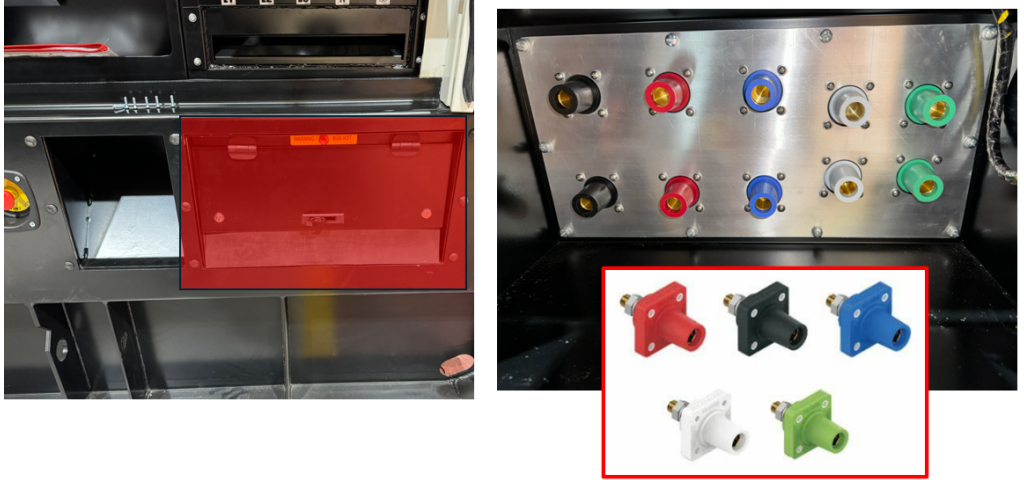
| <b>Location:</b> | Camlock Box | |

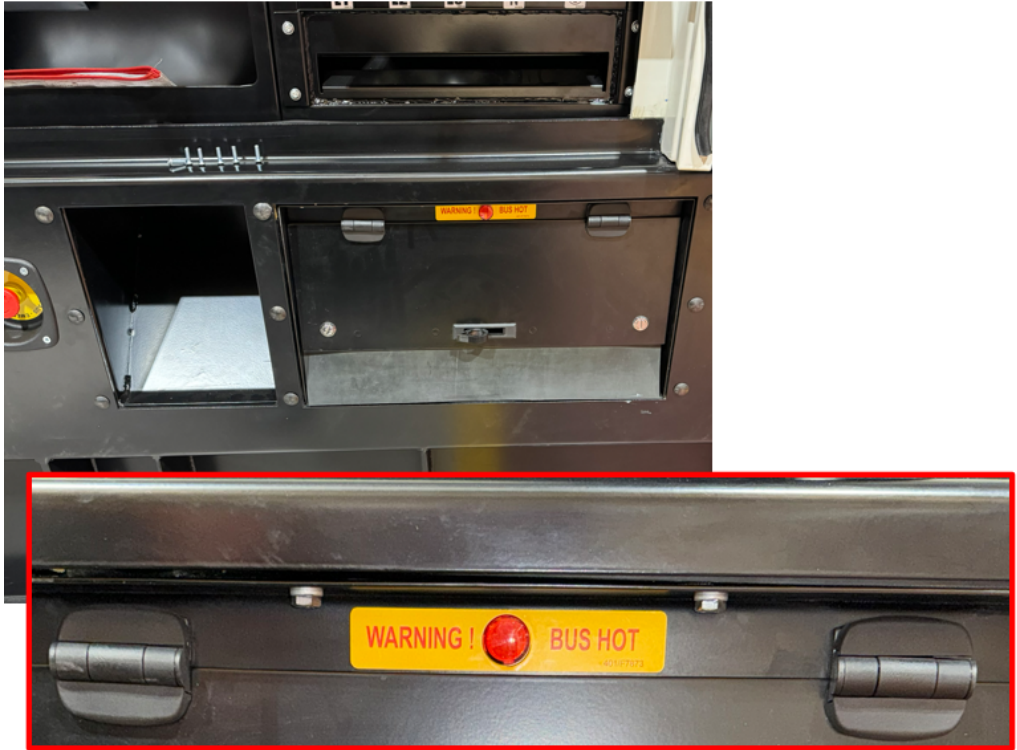
| <b>Location:</b> | Camlock Box |

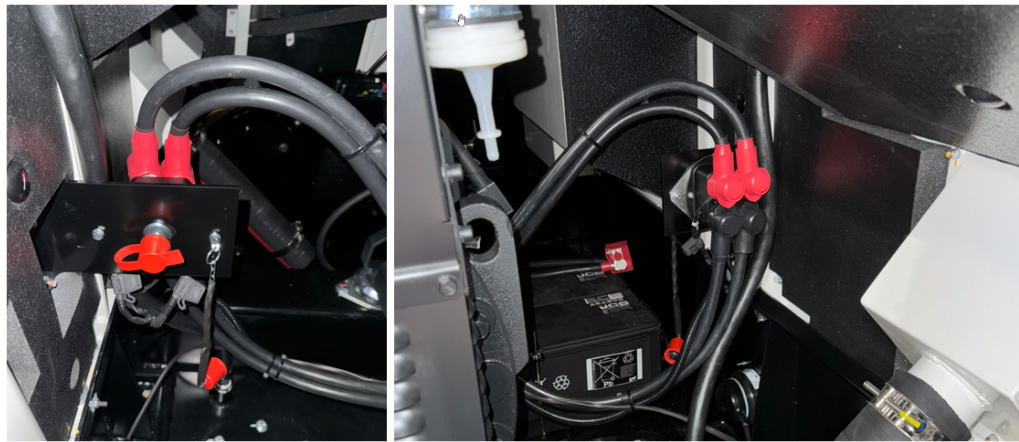
| <b>Location:</b> | Near Batteries in Canopy . | |

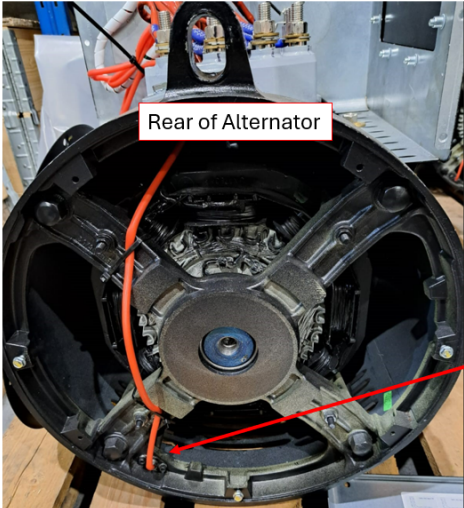
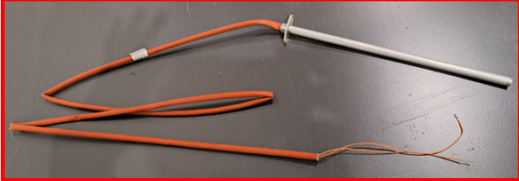
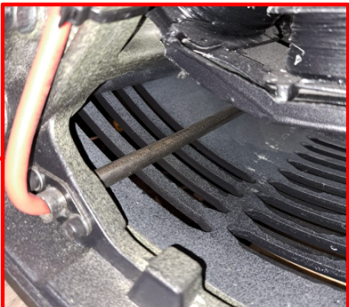
| <b>Location:</b> | Located at the rear of the alternator behind air intake panel. |

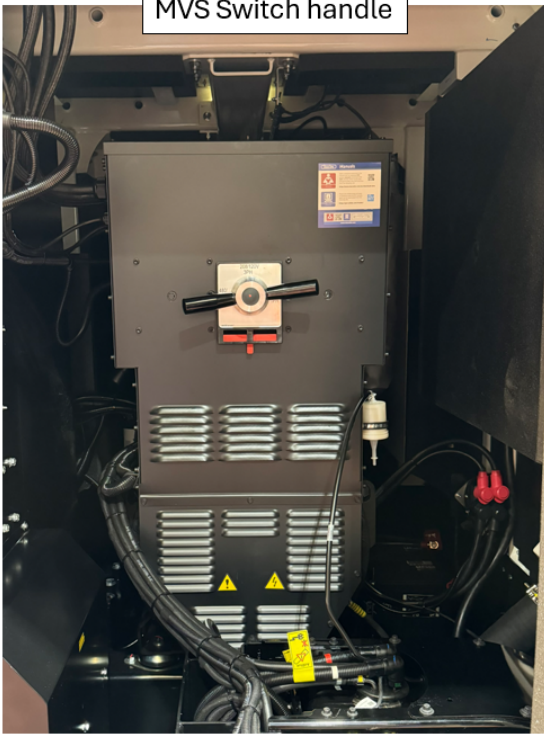
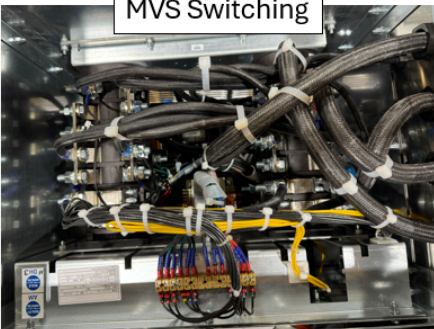
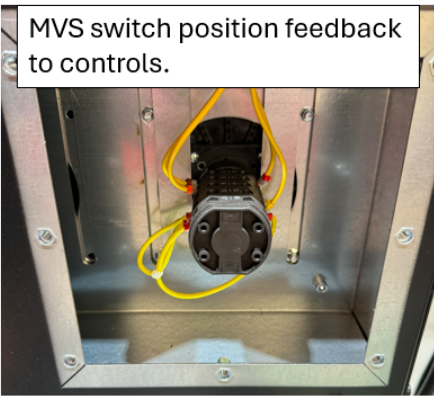
| <b>Location:</b> | Inside generator canopy, located at the rear of the alternators control box which is directly mounted to the alternators top side. Also accessible from the genset rear door. |

| <b>Location<br/>IMG:</b> | <div><div>MVS Switch handle</div><div>MVS Switching</div><div>MVS switch position feedback to controls.</div></div> |

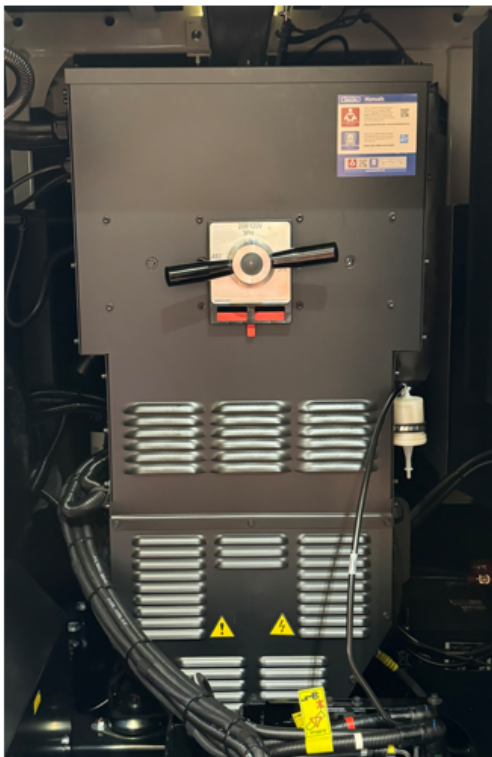
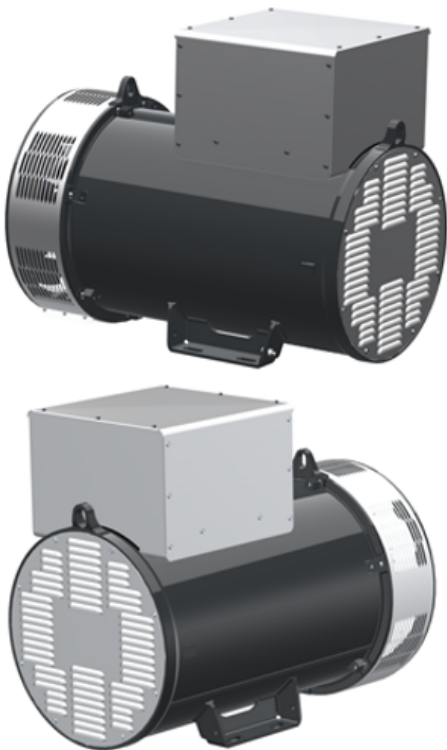
| <b>Location:</b> | Beneath Genset canopy, coupled at the rear of the engine. |

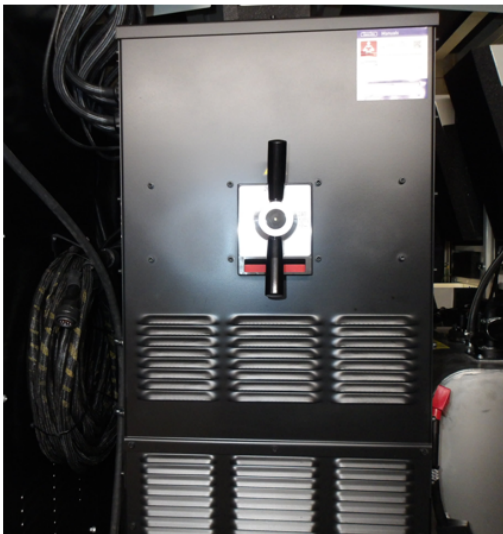
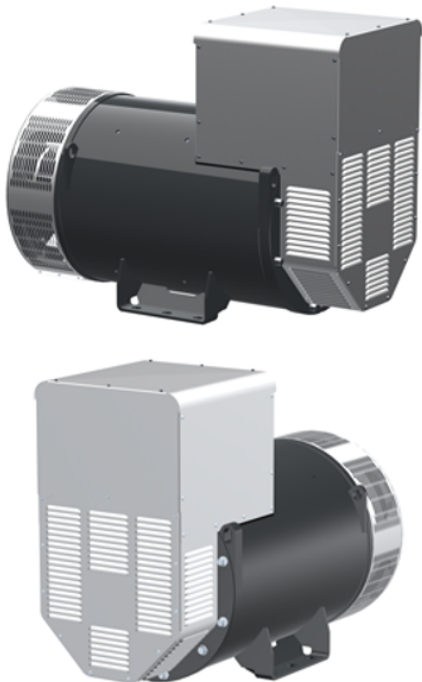
| <b>Location:</b> | Beneath Genset canopy, coupled at the rear of the engine. |

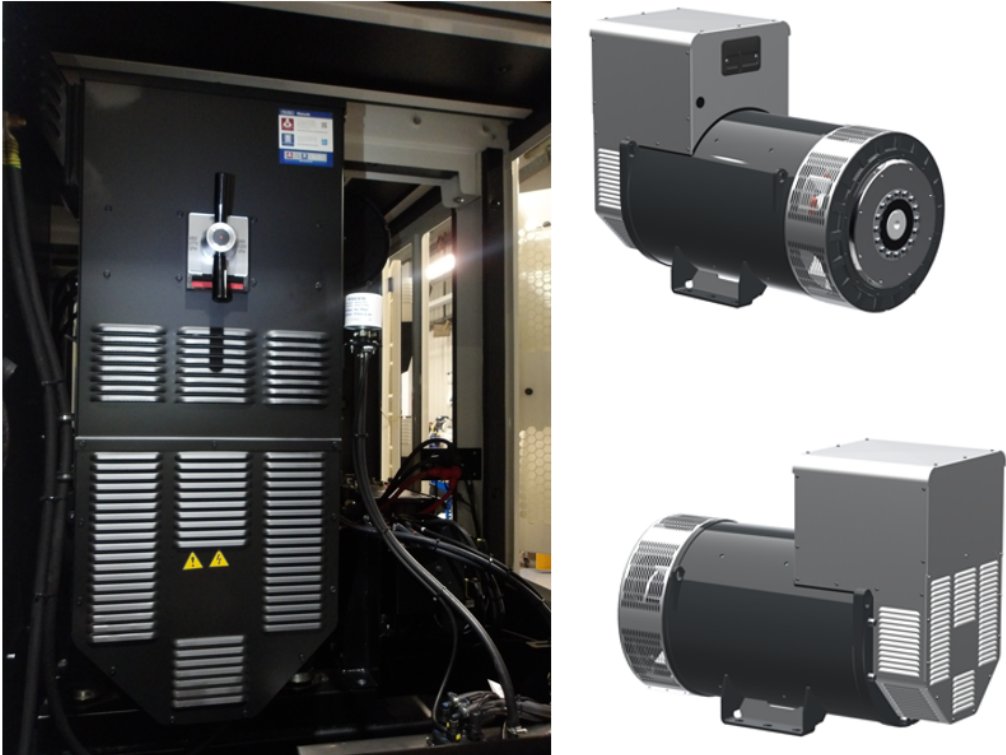
| <b>Location:</b> | Beneath Genset canopy, coupled at the rear of the engine. |
